# Cultural Landscape Report

## The Browning Ranch Blanco County, Texas

Laura Knott,  
Jeffrey Chusid  
and the  
University of Texas School of Architecture  
Historic Preservation Program  
Cultural Landscape Class of Spring, 2003.

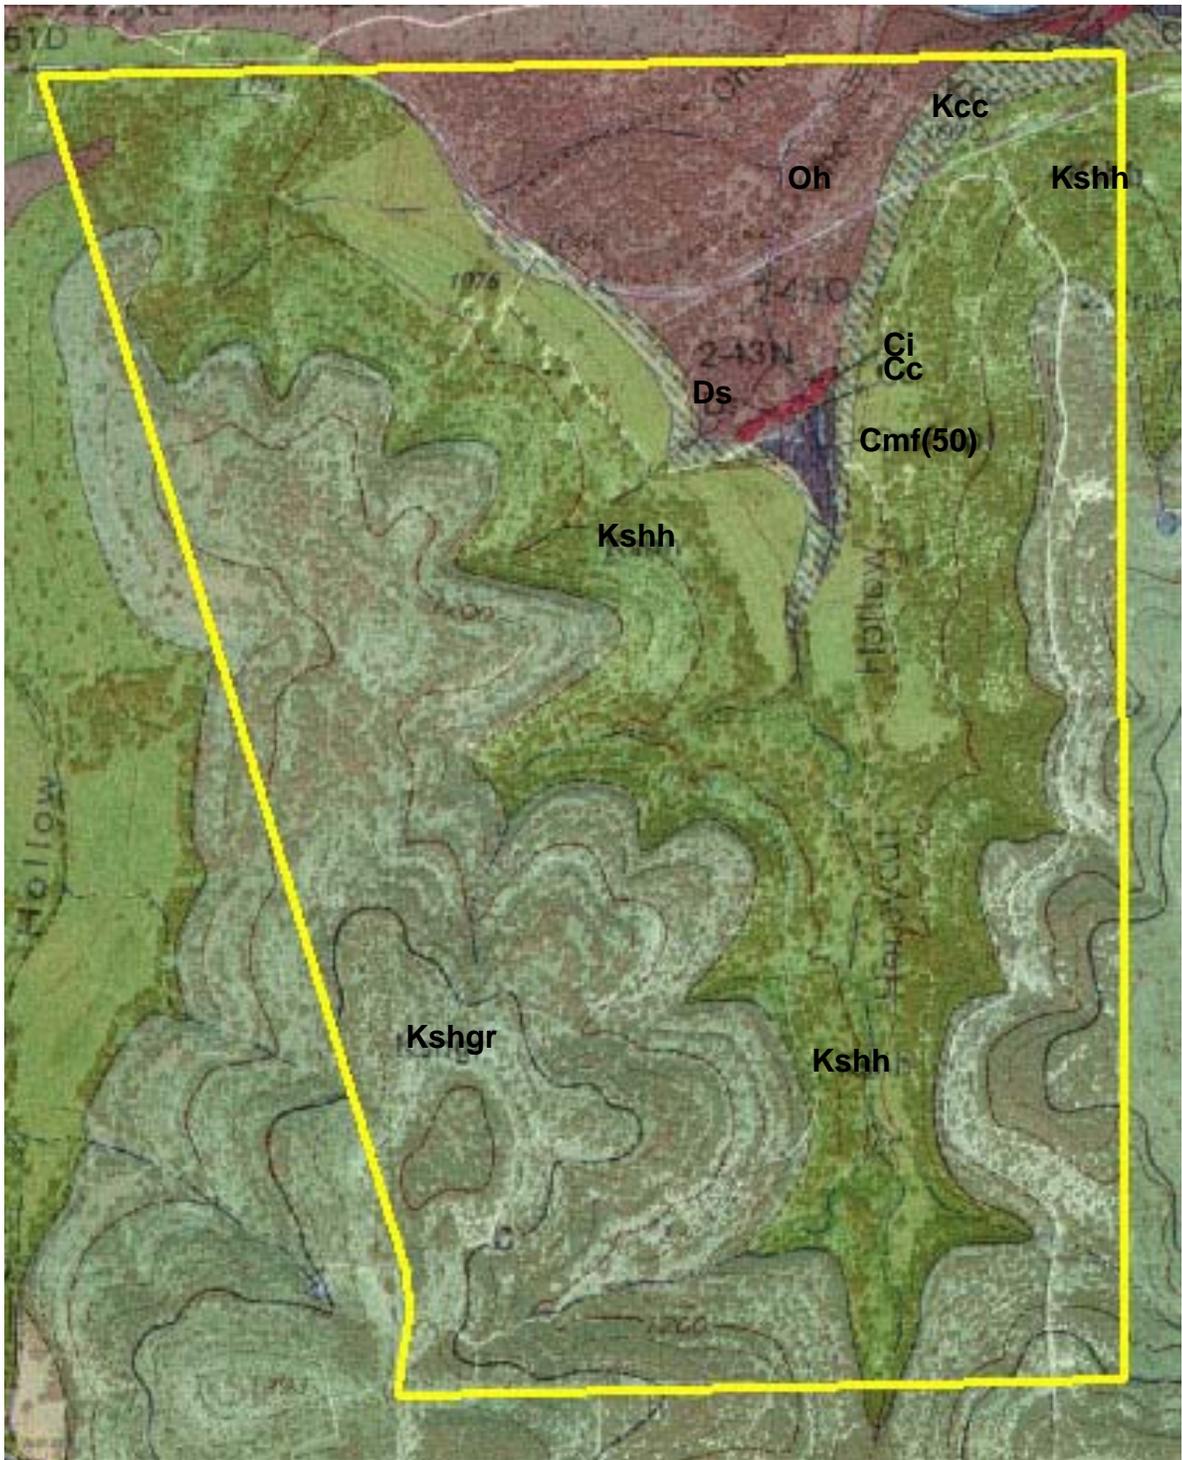
Figure 3. Geologic map with ortho photo. Compiled by Kara Dotter.

At the Browning Ranch, a significant portion of the rock exposed at the surface is composed of three of several rock formations which comprise the Cretaceous strata of central Texas. Towards the north of the property, the exposed rock strata increase in age through Pennsylvanian, Mississippian, and Devonian periods to a formation deposited during the Ordovician period, more than 441 million years ago. It is important to understand these different formations, because they are the sources of the different types of soil found on the ranch. Following is a description of the eight formations found at the surface of the Ranch property, from oldest to youngest, and based on samples collected from the northern portion of the Ranch (Figure 3)<sup>i</sup>

*Glen Rose Limestone Member:* Composed of alternating beds of limestone, dolomite, clay, silt, and sand. The alternating beds have different resistances to erosion, thus resulting in the characteristic stairstep topography of this formation. Fossils are found in the limestone, including the echinoderm *Salenia texana* and the pelecypod *Corbula*, as well as gastropods and other pelecypods. In this area, the Glen Rose forms ridges and marks the highest parts of the property.

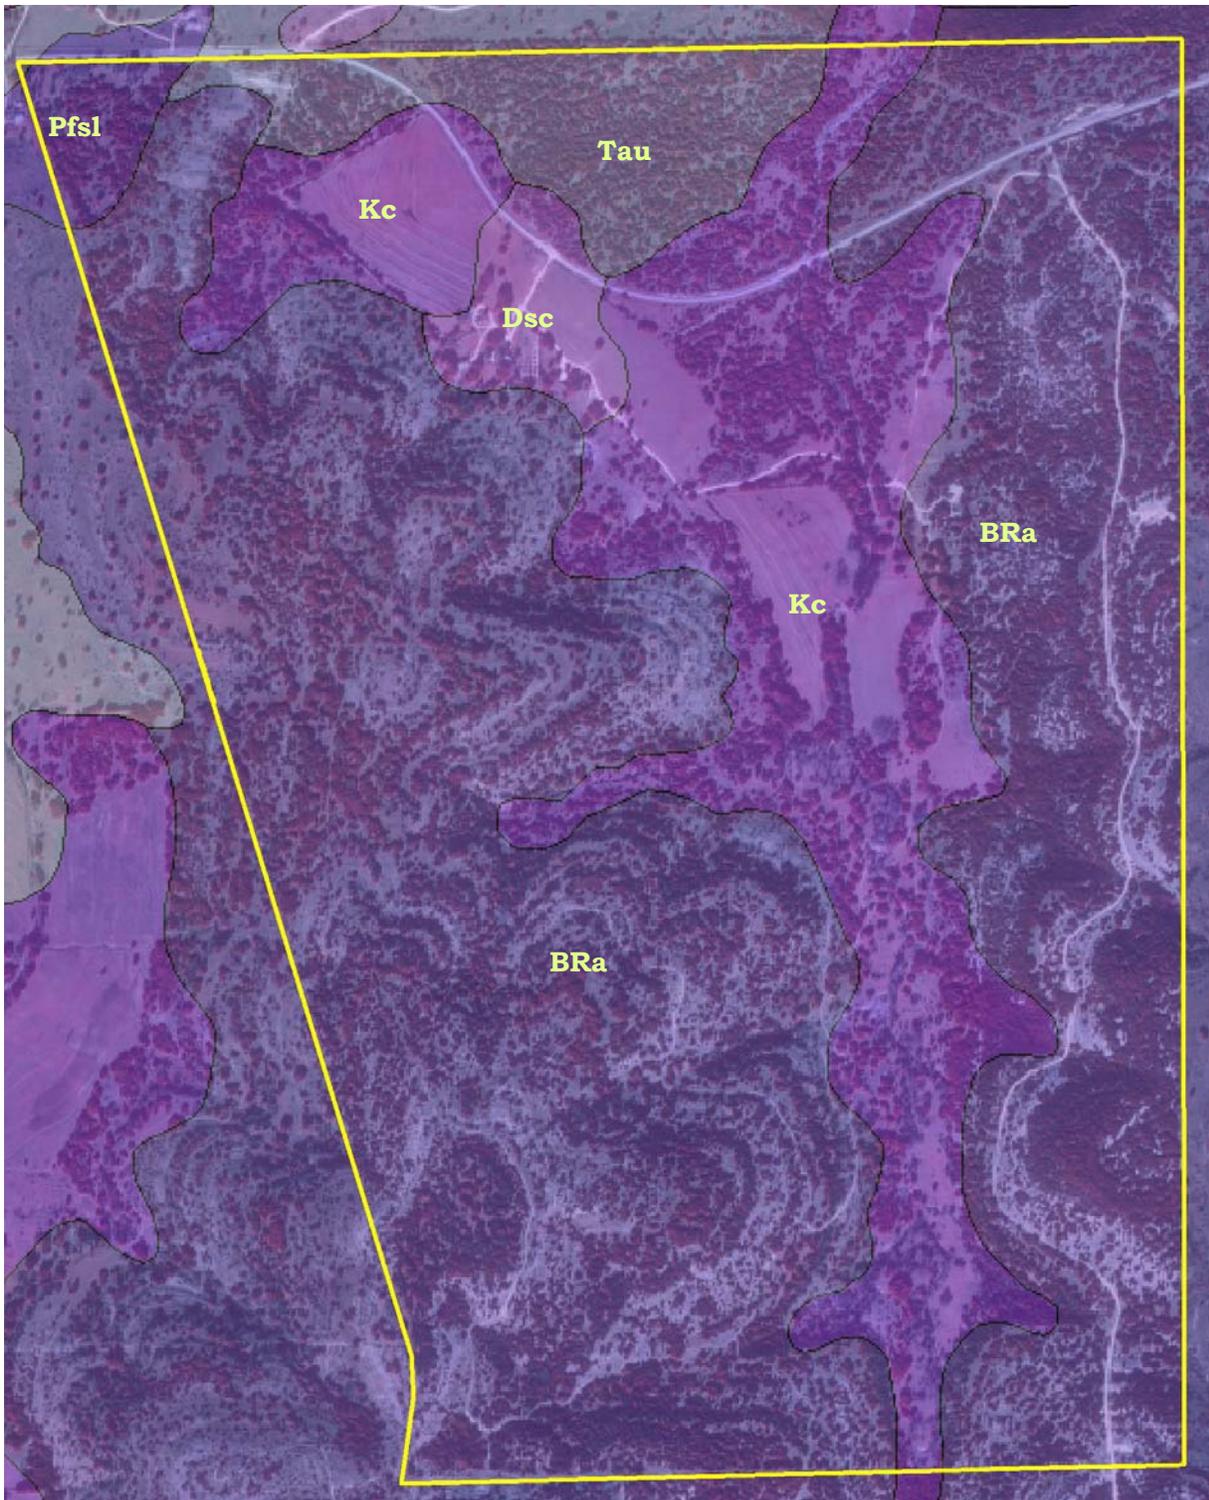
Figure 4. Soils map with ortho photo. Compiled by Kara Dotter.

The soils found on the ranch are of five distinct types, numbered 7, 9, 25, 36, and 42 in the *Soil Survey of Blanco and Burnet Counties, Texas*. The soils are as follows, in order of decreasing abundance (Figure 4):<sup>ii</sup>

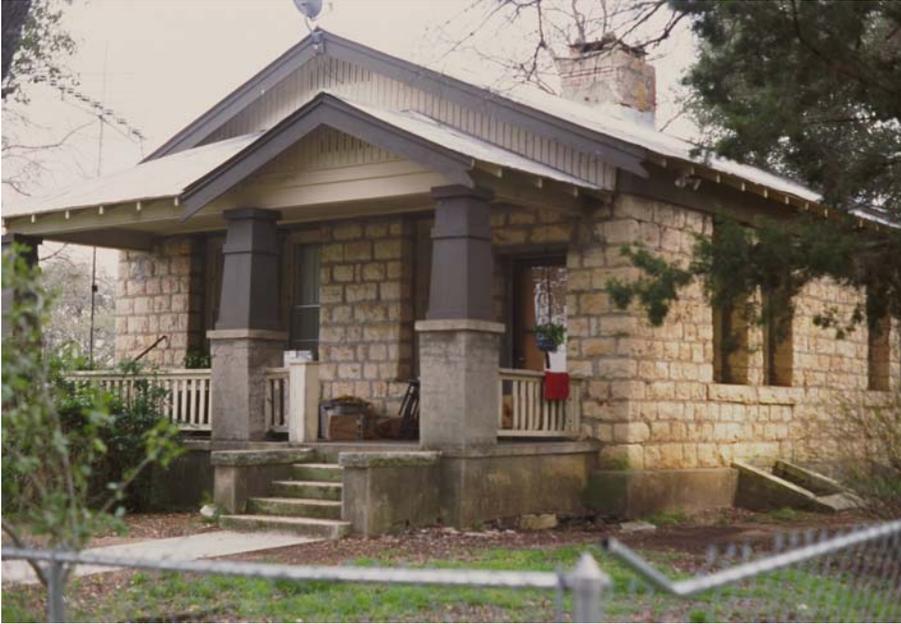
**Figure 7. Barnwell House. Photo by Laura Knott.**

Today, the Barnwell House may be suffering from structural instability, most likely caused by water infiltration into the basement, which may be undermining the foundation. As a result there are many instances of cracking in the mortar joints and even individual stones, although this is not reflected in the interior of the house, which shows little evidence of shifting. The cracking may have occurred before the latest renovation and the foundation may have stabilized since then.

The oldest part of the building is supported by the walls of a full-depth basement below, which was used for storing canned foods from the garden. There is a chimney rising from the middle of the basement floor to which a stove or furnace may have been attached. The building appears to be constructed of wood frame resting on this foundation wall, with the limestone exterior acting only as a veneer and not as a supporting element. The exterior limestone shell is held in place with the frame structure by a concrete bond beam around the top of the wall. The addition on the rear of the building is a wood frame structure resting on a pier and beam system. The roof framing has been examined by a structural engineer and noted as being built out of 20<sup>th</sup> century planed lumber and in good condition.

The change wrought to the building after the fire resulted in a somewhat awkward renovation, most evident in a strange asymmetry on the north façade. The fire also may have cracked the original mortar, a soft, sand-based material, which was later repaired, and poorly, with a Portland cement. This cement, because of its impermeability, has exacerbated the cracking problem. Notable, also, is the pinkish discoloration around some of the window openings, which is the result of intense heat or fire in contact with this type of local limestone.

As mentioned before, the house is plagued by a continual leak into the basement, which is being currently dealt with by the use of a sump pump. The source of this leak is as yet unknown, but may be the result of a break in one of the water lines being fed by the cistern on the hillside above the house. It may also be fed by a seep, of which there are many on the property.

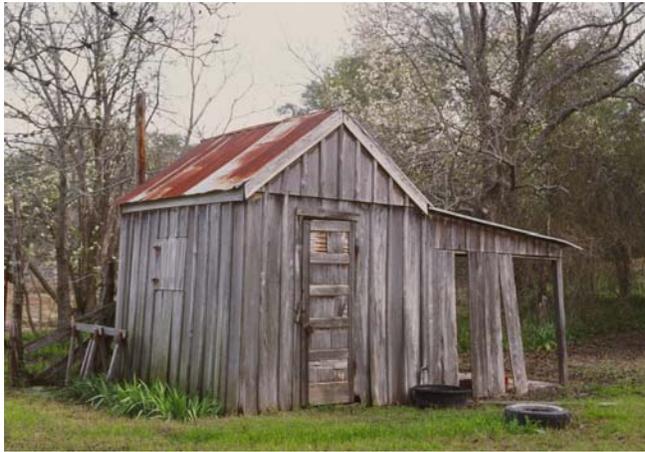
**Figure 8. Smoke House. Photo by Laura Knott**

The smoke room still has hooks in the ceiling from which meat used to be hung. In the middle of the floor is a half-barrel full of ashes and what appear to be small chunks of cypress or cedar. It is possible that this was the source of smoke for the room, but it may have also been used to heat water on the laundry porch--the current owner recalls that Mrs. Nauman did laundry over a wood fire.<sup>7</sup> A large weighing scale and a sausage-stuffing mechanism were also found in the smoke house, which is not surprising because a former foreman recalled that the smoke house was in active use up until 1996.<sup>8</sup>

This building matches the description of a Pennsylvania German type of smokehouse.<sup>9</sup> Usually square or rectangular, they are typically 6'-8' on a side and 8'-12' tall--this one is slightly larger in plan, but does not exceed the typical height. These structures are also usually of frame construction with wooden siding and battens to cover the joints as well as gable end doors, as found in this building. Although the German smoke-houses do not typically have windows, this one does, but with stout shutters. The windows may have been added to replace the upper flue, which is typical but absent in this building.

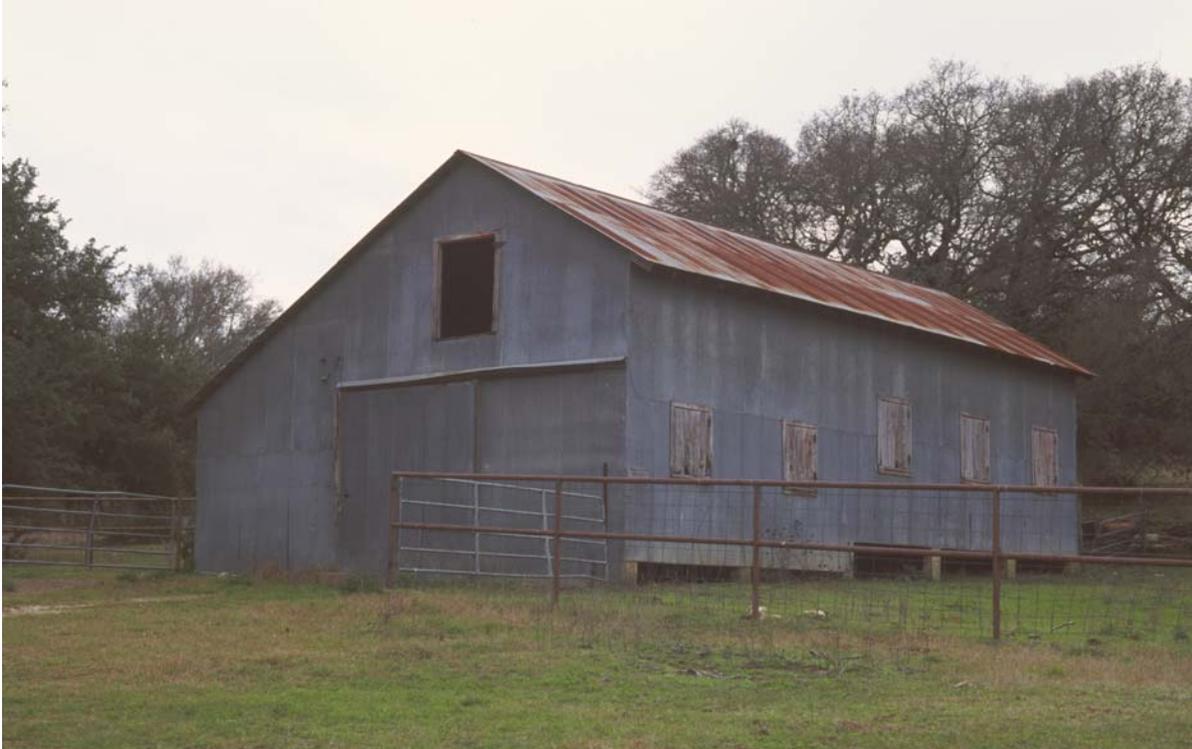
**Figure 9. Horse barn, view from the northeast. Photo by Laura Knott.**

The horse barn is located within the agricultural complex at just a short distance from the Barnwell House (Figure 9 and Appendix B). Situated on a gentle slope at the base of a steeper hill, the building appears larger than it actually is when viewed from the main approach. This wood-framed building measures only 30'x50' and is 21' tall at the east end, but the fact that it is almost entirely clad in grey corrugated steel siding emphasizes its positive form. The northeast façades are broken only by five small windows on the north side, which are usually shuttered; a sliding door, which is usually closed; and the shutter-less hay loft opening, which lends a sense of mystery because it is always dark. The live oaks clustered around the west end hide the hill behind it and give the barn more presence, emphasizing its mass when viewed from the northeast. The exact construction date of this barn is not known, but a former foreman of the ranch recalls that it may have been built by the C.L. Browning Construction Company not too long after C.L. Browning purchased the ranch in 1942.<sup>10</sup>

A broad central driveway divides the interior of the barn into three main spaces with a bank of five storage rooms to the north and five horse stalls to the south. The wooden floors of the storage rooms are supported above the ground by 6x6 posts mounted on concrete footings. Being on the north side of the building, they provide additional protection to the animals during the winter. These rooms currently contain a variety of items, including farm chemicals and tools, saddles, chairs, and empty feed bags.

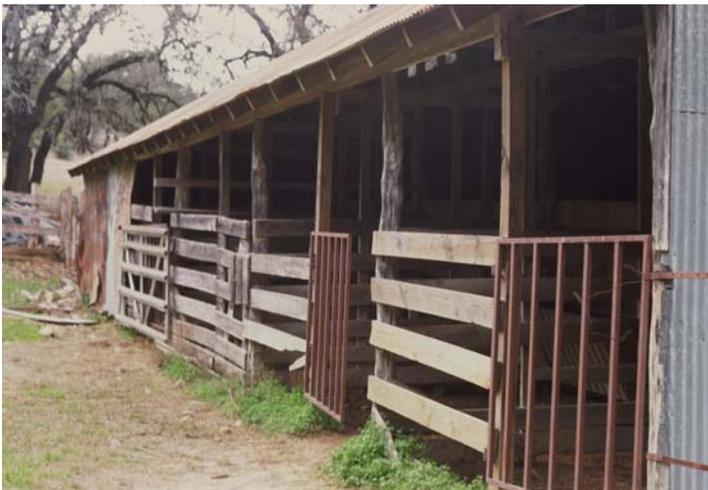
**Figure 10. South side of horse barn. Photo by Laura Knott.**

The five stalls on the south side are enclosed on the interior by plank half-walls and doors (Figure 10). With the exception of the far west stall, they are enclosed on the south wall by a combination of open plank fences and metal gates, leaving the stalls fairly open to the heating qualities of the sun in the winter. The far west stall has a raised wooden floor but the others have earthen floors, which indicates that it was used to house sick or otherwise vulnerable animals, such as foaling mares. The stall side of the barn is supported by a combination of tall cedar posts and 4x4 posts attached to cedar stumps set into the ground. The stall doors feature charming hand-made latches that lock by sliding the tongue of the latch into a carved opening in the adjacent cedar post. Other interesting

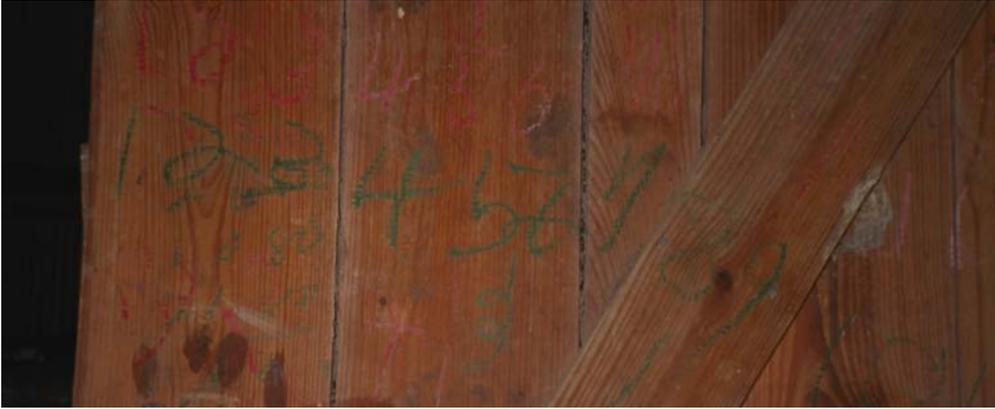
details include a variety of hinges throughout the structure (Appendix B), which may indicate different stages of construction as well as chalk markings on some of the doors, possibly calculations (Figure 11).

Figure 11. Chalk numbers on storage room door. Photo by Laura Knott.

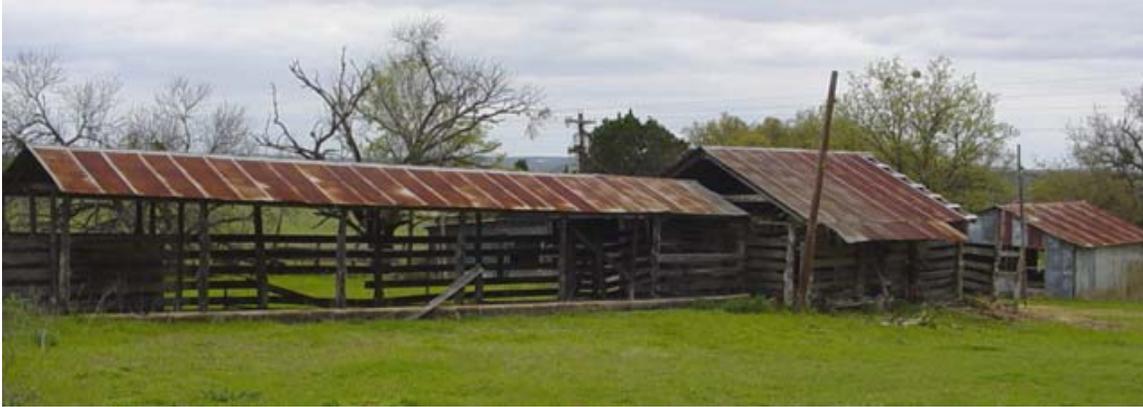
The size and design of the large sheep dip facility on the Browning Ranch (Figure 12 and Appendix B) represents a significant capital investment. It is assumed, therefore, that this was a major agricultural operation and possible source of extra income for the ranch. The sheep dip operation was probably a facility shared by the surrounding ranching community. According to the current ranch manager, this particular facility was probably unique to this ranch and sheep dipping as a ranch community activity was not uncommon.<sup>14</sup> Sheep ranchers on surrounding properties may well have brought their sheep here and shared the expense of needed chemicals, materials and labor.

Figure 12. Sheep dip facility. Photo by Bob Yard.

The purpose of the structure was to treat sheep against various external parasites. The animals were gathered up into holding pens and then herded into a shoot, which leads to a long open concrete tank buried in the ground and sheltered by a metal roof. This tank was partially filled with a chemical solution as the treating agent, diluted in water. The animals were lead into and through the solution to an enclosed corral at the opposite end where they could, again, be collected in pens. Various gates allowed sorting of the animals as necessary. A later discussion will address the most common chemical used, Coopertox, its subsequent ban by the EPA in 1983 and suggest the potential need for chemical waste disposal and abatement.

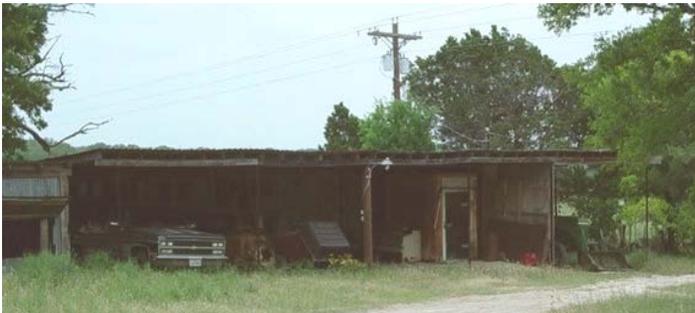
Figure 13. Machine shed. Photo by Bob Yard.

The machine shed is an open metal-pole structure enclosed on three sides by corrugated sheet metal. It also contains one interior sheet-metal wall, dividing the space into two areas, one which currently houses a tractor and the other which is used to store other machinery (Figure 13, Appendix B).

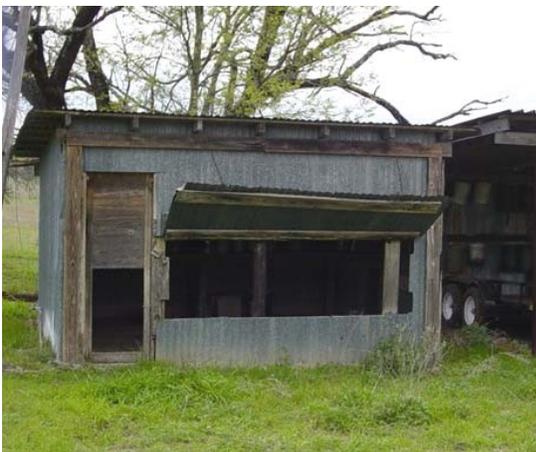
Figure14. Electrified chicken coop. Photo by Bob Yard.

The chicken coop is a wood-framed structure with corrugated metal siding and it appears to have been electrified at one time (Figure 14, Appendix B). Since the building is completely enclosed, it probably provided some protection from predators and may have been used for laying hens. Three low shed structures which appear to be another type of chicken coop are located to the south and west of the horse barn and may have been used for stewing or frying chickens (Figure 15). Due to the number and size of the coops it may be that chickens were sold as part of the agricultural business.

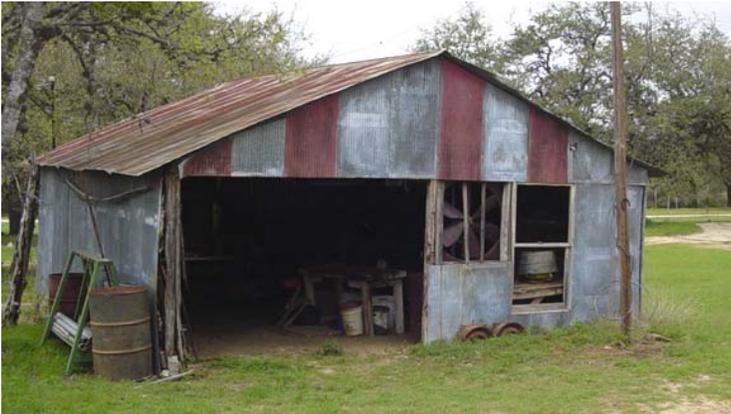
Figure 16. Workshop. Photo by Bob Yard.

The workshop is also a wood-framed building with corrugated metal siding (Figure 16 and Appendix B) and contains many hand and power tools, which are typically associated with building construction, maintenance, and repair and are commonly found associated with ranch or farm operations.

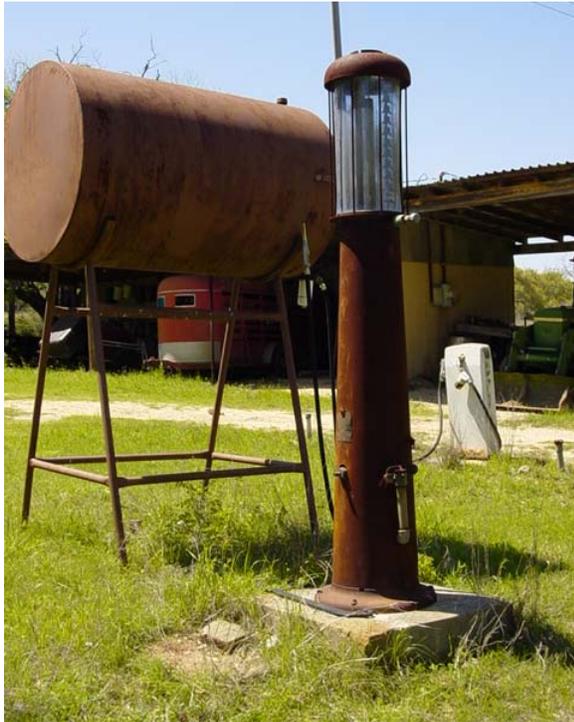
**Figure 17. Left to right: Above ground fuel tank, 1920's gas pump, and 1940's gas pump. Photo by Bob Yard.**

ranch today support the assumption that its operation was becoming gas-powered during the late 1920's and early 1930's. One old fuel pump located near the workshop can be dated to that time frame and another dated to the 1940's (Figure 17). All the agricultural implements found on the site during recent fieldwork and discussed below would have been pulled by a gas powered tractor and the majority are, or have been, used for soil cultivation and management.

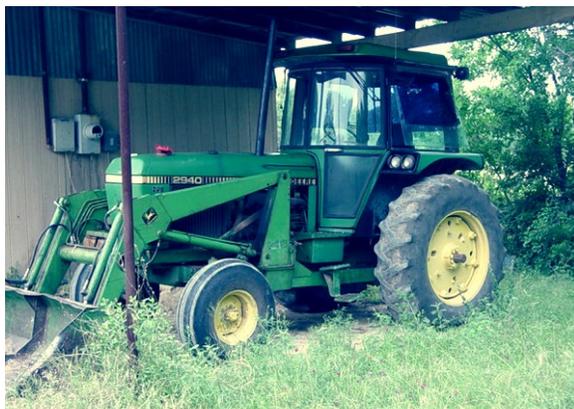
**Figure 18. John Deere tractor. Photo by Bob Yard.**

According to a former foreman, a Ford tractor with implements was purchased in the 1953-54-time period,<sup>16</sup> but this tractor is no longer located on the property. During spring, 2003, a John Deere Model 2940 with a front loader and an enclosed cab was found stored in the machine shed (Figure 18). This diesel-powered tractor has a model number which indicates manufacture sometime between 1980 and 1982. It is in serviceable and operating condition.

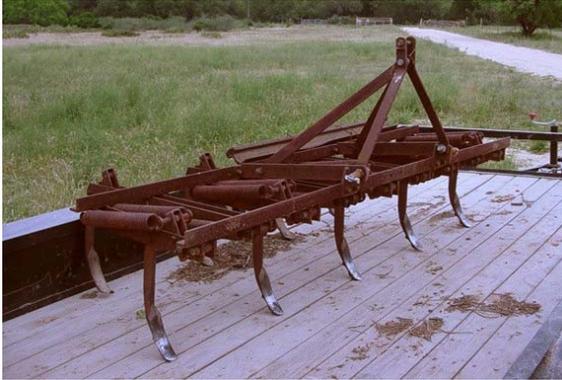
**Figure 19. Nine-shank tiller. Photo by Bob Yard.**

One of the cultivation implements found on the ranch is a nine-shank tiller, which is used for initial plowing in a previous planted field and is usually pulled by a tractor with a three-point hitch connection (Figure 19). The shanks, or rippers, are spring loaded to allow them to release from stumps or rocks while operating. The manufacturer and date of manufacture is not known. It has surface oxidation but is still a useable piece of equipment.

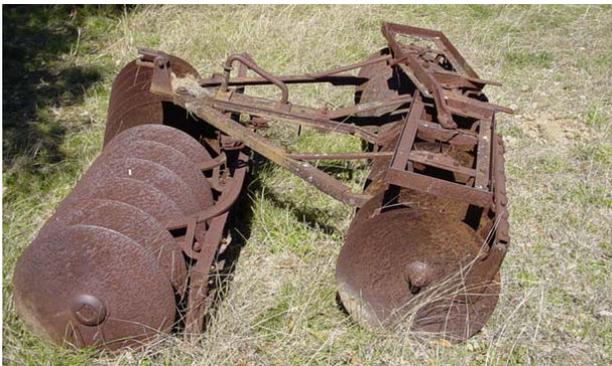
**Figure20. Disc harrow. Photo by Bob Yard.**

The disc harrow, currently located to the east of the machine shed, is actually two pieces of equipment that are joined and pulled by a tractor using a draw bar (Figure 20). This device is used to further break up the soil following plowing and before planting. It is a Ferguson Sherman Model A-BO-20, and was manufactured sometime between 1940 and 1942.

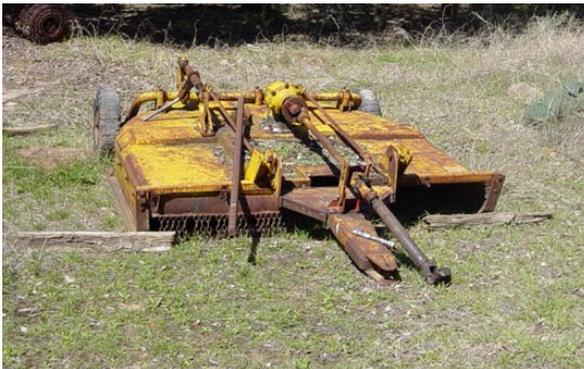
**Figure21. Brush hog. Photo by Bob Yard.**

A six-foot shredder or "brush hog" is also stored near the machine shed (Figure 21). This implement is used to cut rough pasture and low growing brush and is operated by a power take-off (PTO) unit. The front guard is missing on the left side of the machine and the operating condition of this machine is unknown. It is a Model 72 Serial # 004410, manufactured by the Servis Equipment Company after 1948.

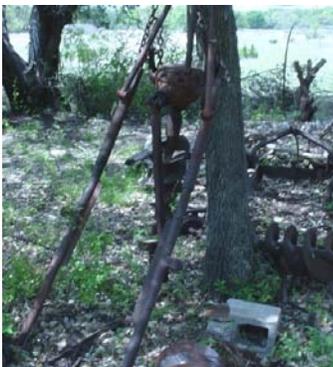
**Figure22. Post-hole digger. Photo by Bob Yard.**

There is a post-hole digger located close to the shredder and is also operated by a PTO and mounted on the three-point hitch (Figure 22). The Danuser Equipment, Fulton, Missouri, was the manufacturer but the date of manufacture is unknown. It appears to still be a serviceable piece of equipment.

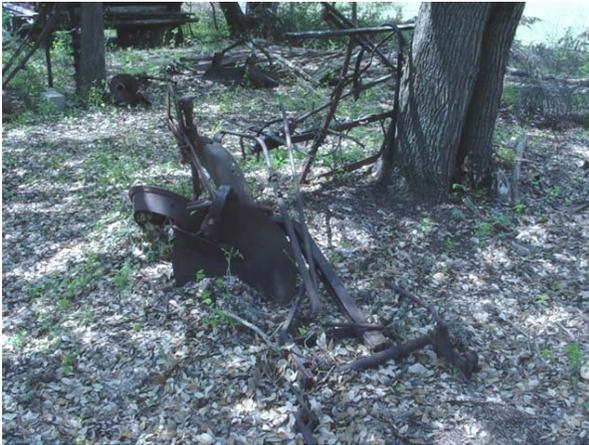
**Figure23. Economy plow. Photo by Bob Yard.**

A Dearborn 10-152 plow, sometimes called an economy plow, is located with the other equipment near the machine shed (Figure 23). It would have been pulled by a Ford tractor and is typically used on heavy clay soils or land which has been fallow for some time--that is, plowed but not replanted every season. It is rusty and appears to be missing the plow boards. Serviceability is unknown.

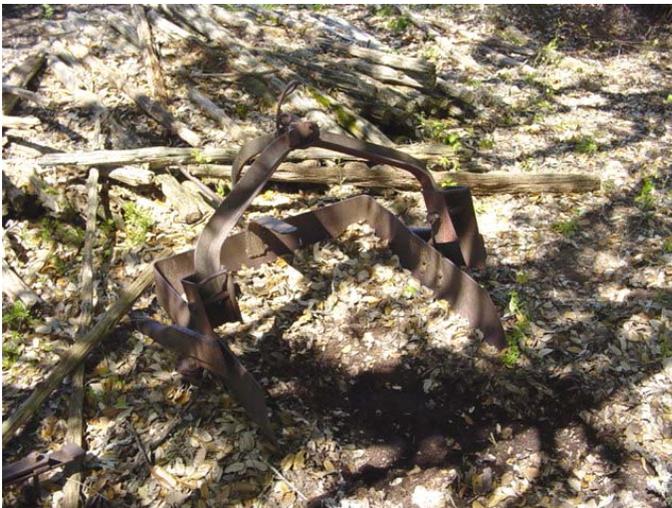
**Figure 24. Materials scoop. Photo by Bob Yard.**

A materials scoop, located close to the post-hole digger, may be either pushed or pulled by a small tractor, such as, 8N Ford tractor. The manufacturer and date of manufacture are not known. It is rusty, but probably still useable (Figure 24).

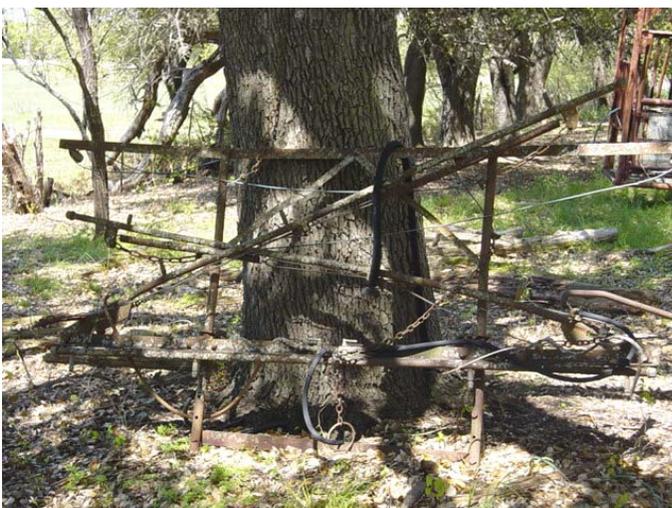
**Figure 25. Sprayer. Photo by Bob Yard.**

A sprayer, also found close to the post-hole digger, would have been attached to a tractor with a portable tank to spray fields with insecticides, herbicides or fertilizers (Figure 25). The arms swing out to cover a large area with each pass along the field. It appears to be badly deteriorated and unserviceable and the manufacturer and date of manufacture are unknown.

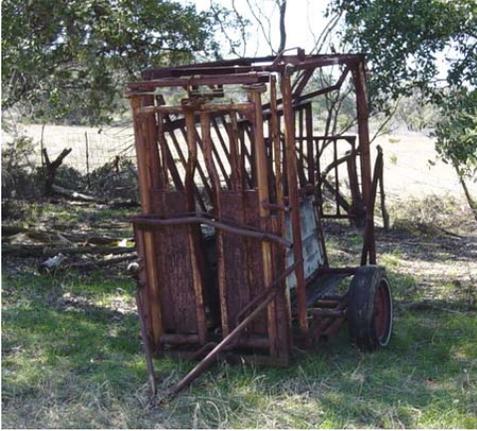
**Figure26. Portable squeeze shoot. Photo by Bob Yard.**

A portable squeeze shoot located on the site was identified as the type that can be moved around by a truck or a tractor (Figure 26). It is used to hold sheep or calves for shots and tagging for identification, or any number of other procedures for which an animal would not stand still. Most of the wooden pieces are rotten as well as the tires but it could be made serviceable with some work. There are no equipment manufacturing tags or other types of identification on this piece of equipment, so the make, model, and age are unknown.

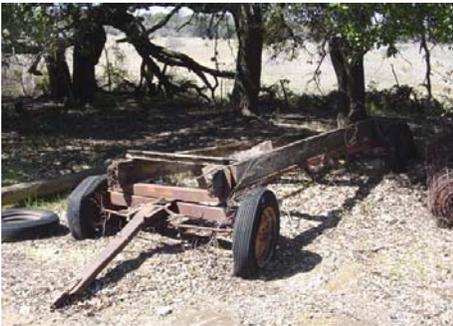
**Figure 27. Farm wagon. Photo by Bob Yard.**

Also found on the site is a farm wagon that could be pulled by a truck or a tractor (Figure 27). It is manufactured by the Dearborn Farm Equipment Company, Dearborn, Michigan and is identified as a Model 21-2. The metal frame is intact but all the wood has rotted away as well as the tires but it could be made serviceable. It is interesting to note that the front wheels turn as the tongue is moved from side to side by a method very similar to a car.

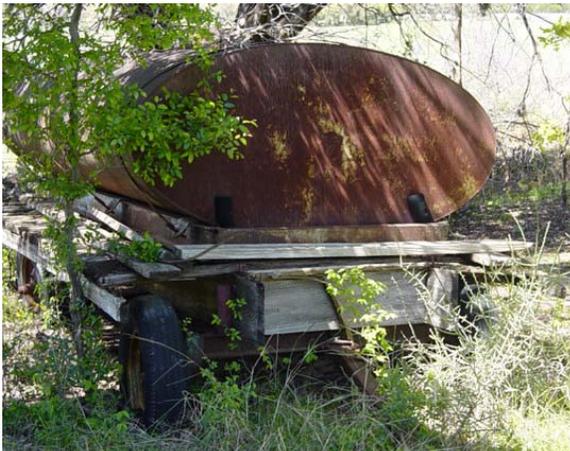
**Figure 28. A portable sprayer tank. Photo by Bob Yard.**

Two portable sprayer tanks with gas- powered pumps were also found on the site (Figure 28). It is possible they were used for treating the orchard trees and the vegetable garden. A heavy -duty portable air compressor with a jackhammer and bit was also found (Figure 29). Typically used for breaking up rock or concrete these are commonly found at construction sites. The operating condition of these machines is unknown.

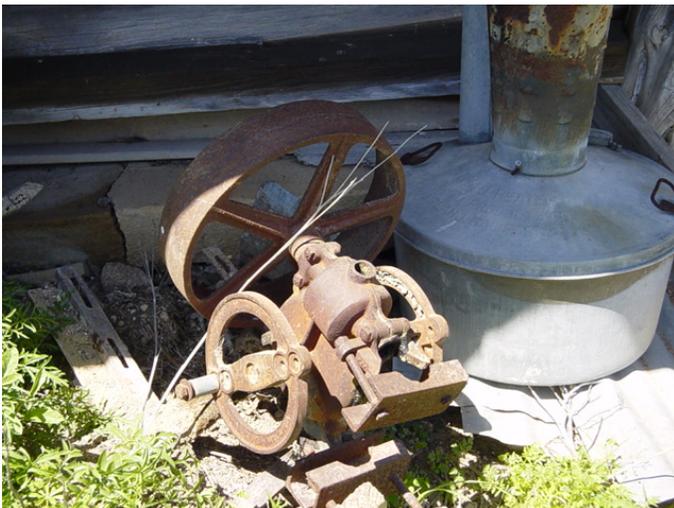
A Dain Pump Jack, typically used to automate hand-operated well pumps, was also located in the machine shed (Figure 30). It was probably belt-driven by a tractor or stationary motor. It would probably be serviceable with some repair.

Figure 30. Dain jack pump. Photo by Bob Yard

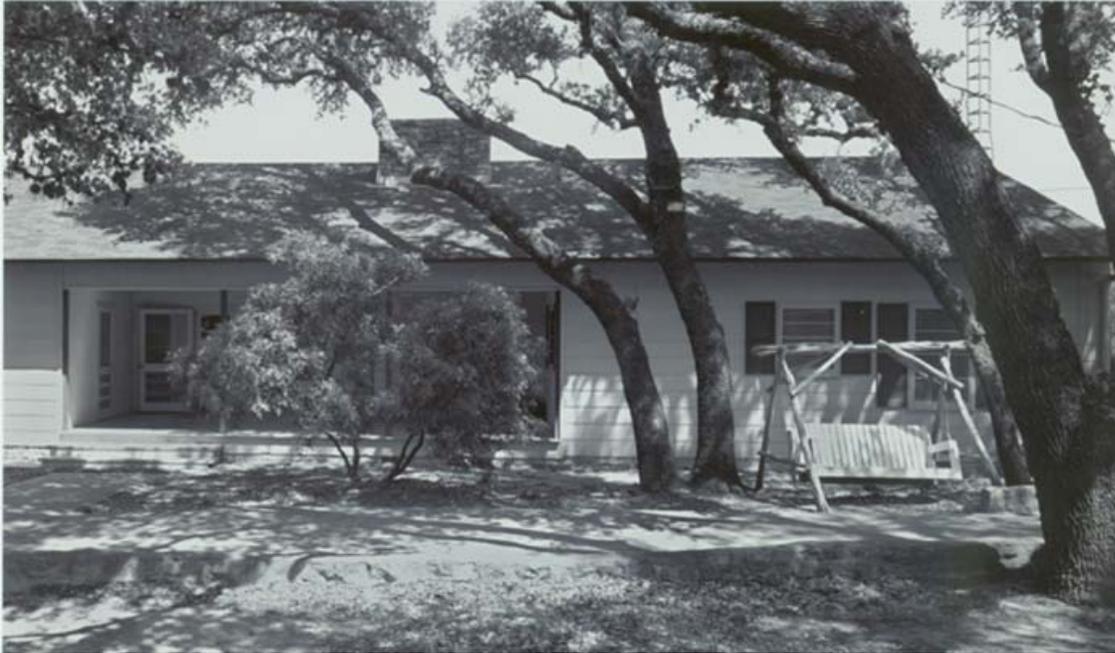
This complex includes the ranch house, its yard as demarcated by a pipe rail fence, the garage and apartment to the west, and a gravel parking area. The ranch house was built in 1942 by C.L. Browning for his San Antonio-based family to use as a weekend and summer residence (Figure 31 and Appendix B). Workers from the C. L. Browning construction company built not only the ranch house but other buildings and structures on the property. Photographic evidence shows that the garage and apartment which is part of this complex was constructed some time after the ranch house, but it is not know in which year this occurred.

**Figure 31. Ranch house. Photo by Sarah Benson.**

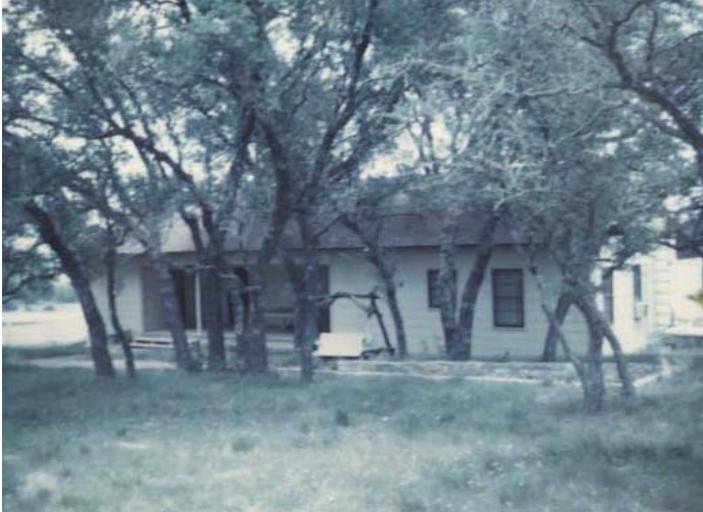
A broad stone chimney of random ashlar masonry in various grey and beige hues rises through the center of the house; its outside face is a prominent feature of the entry porch (Figure 32). The greyer limestone appears to have come from the site because there is an outcrop, called the Honeycut Formation which matches this stone and may have actually been taken from the northern section of the stone fence. The beige limestone appears to have been taken from the Glen Rose outcrop, also found on the site. It is unclear why these different types are arranged in such a pattern, except, possibly for the simple sake of convenience during construction. On its north side, this chimney bears a divot, which was made by an errant bullet from a loaded gun belonging to one of Mr. Browning's guests.<sup>19</sup> Another, much smaller, stone chimney rises out of the roof over the kitchen. A large antenna is mounted on a triangular metal tower about twice the height of the house, at its south end. Old photographs indicate that this tower was installed around the time the ranch house was constructed (Figure 33).

**Figure 33. Ranch house, probably just after construction, no date. Photographer unknown.**

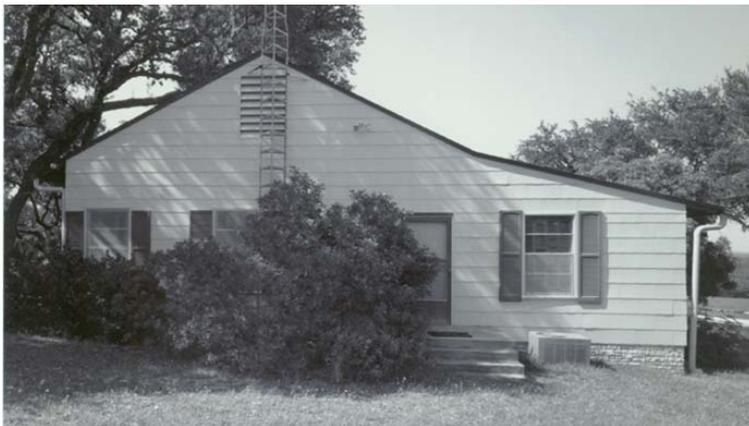
Originally, the house was roughly one room deep, its mass enclosing an entry porch on the west side and running parallel to the screened-in porch on the east side. The entry porch is still intact but the screened-in porch has been enclosed (Figure 34). A small bedroom forms the northwest corner of the house, accessible only from the porch. The screened-porch also partly wrapped around the south end of the house. The floor of the porch was wood, and canted very slightly. The living opened out onto the porch; there are now two large openings between the living room and the former porch. The kitchen was, and still is, accessible from the former porch via a “Dutch” door (Figure 35).

**Figure 34. South end of ranch house showing enclosed porch. Photo by Sarah Benson.**

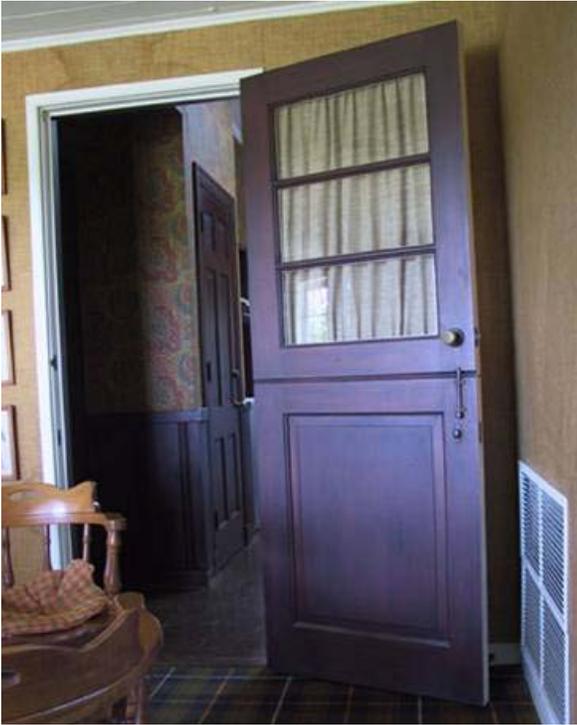
Figure 35. Dutch door. Photo by Sarah Benson.

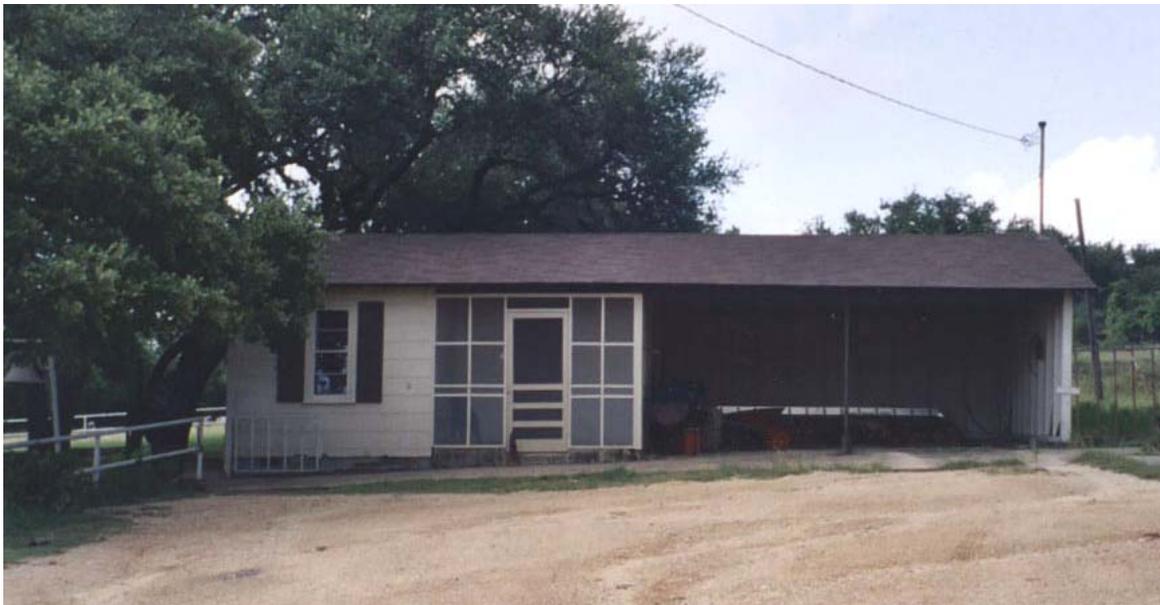
To the east of the ranch house is another building which functions as a garage for vehicles and which also contains a small apartment, as well as a storage room and a screened-in porch (Figure 37). This porch was originally used to hang deer carcasses for cleaning during the hunting season, to keep the flies away from the meat.<sup>20</sup> The apartment was used to house employees of the Browning family, usually their chauffeur, Ralph Morris, who worked for the family from 1962 until Mrs. Browning died in 1992. A photograph of the ranch house, taken probably not long after construction, does not show this building, so it appears that it was constructed somewhere between 1942 and 1962, probably not long after the ranch house was built.

**Figure 37. Garage (right) and apartment (left). Photo by Laura Knott.**

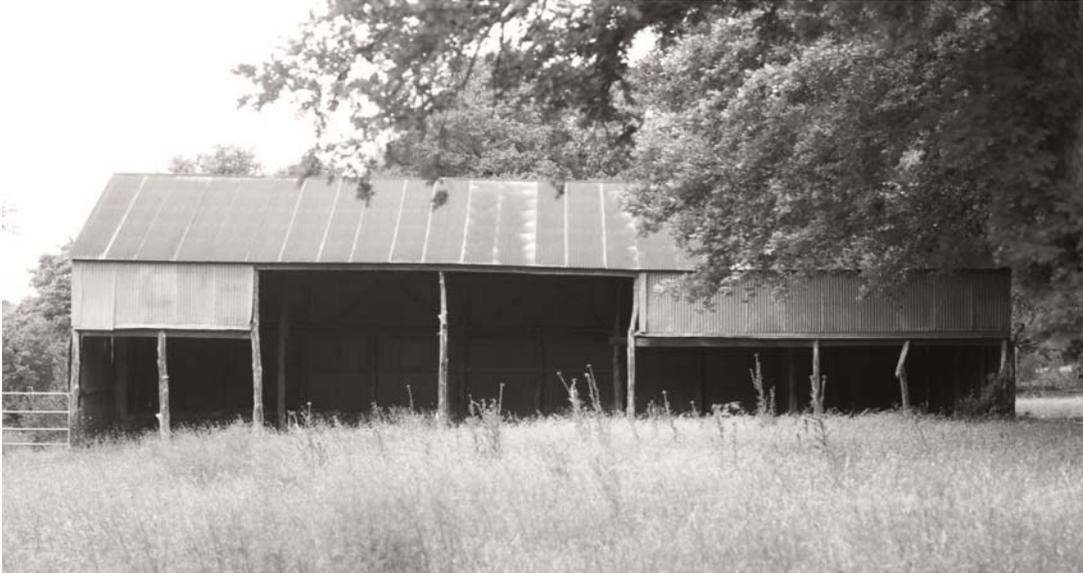
The sheep barn is the only major farm structure on the Browning Ranch not located within the agricultural complex (Figure 38 and Appendix B). It is, in fact, quite remote from the zone of the most intensive farming activity on the property, being around one-half mile, as the crow flies, and one full mile by roadway, from the Barnwell House.

**Figure 38. Sheep barn, south elevation. Photo by Laura Knott.**

The sheep barn is not as massive in appearance as the horse barn; although it is 50' in length, it is only 20' wide and is dwarfed by a large clump of live oaks nearby. Like the horse barn, the sheep barn is of wood-frame construction, as well as roofed and covered on three sides by corrugated steel siding, with a dirt floor. The main wall and center supports are tall cedar posts between 18' and 20' in height, set directly into the ground. The barn contains one main room with a hayloft above, which appears to have, at one time, spanned the entire length of the building. It also appears that the loft was completely enclosed on all sides, but that the lower half of the south side of the barn was open to the exercise yard. The lower one-to-three feet of the north and west sides of the barn are enclosed by a mortared rock wall--rough and unfinished in appearance on the inside, but more refined on the outside face (Figure 39). It is unclear why this wall was constructed, but it appears to be somewhat more recent than the barn itself.

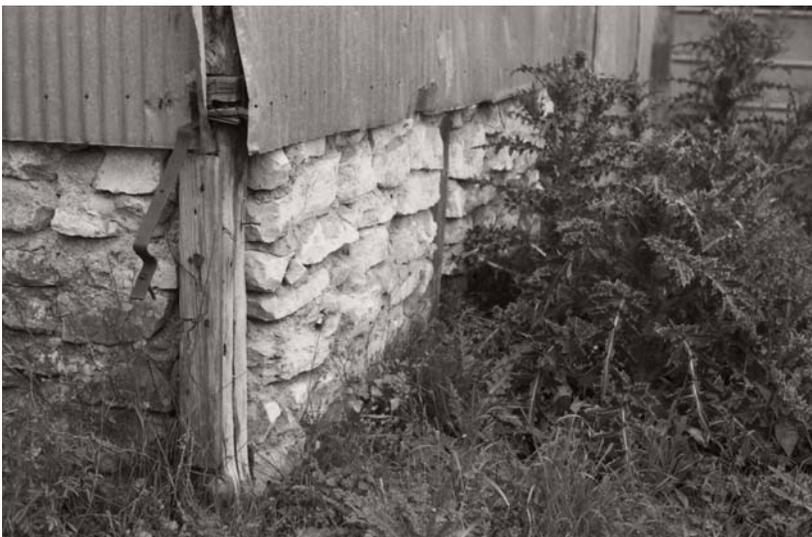
**Figure 39. Sheep barn, north elevation. Photo by Laura Knott.**

The exercise yard enclosure appears to have at least two periods of construction, the first probably concurrent with the barn construction and consisting of a concrete ramp with a wood and wire enclosure, a long chute, and a holding area with four gates. The size of the ramp and the chutes indicate that perhaps this was intended to control sheep (Figure 40). A larger, more robust holding area and chute appears to have been built much later than the first and seems to be at the most ten years old (Figure 41). It is constructed of stout wooden posts, 12” in diameter, which support sturdy cedar paling fence panels. The design and strength of this section of enclosure indicates that it was probably used to control cattle, rather than sheep.

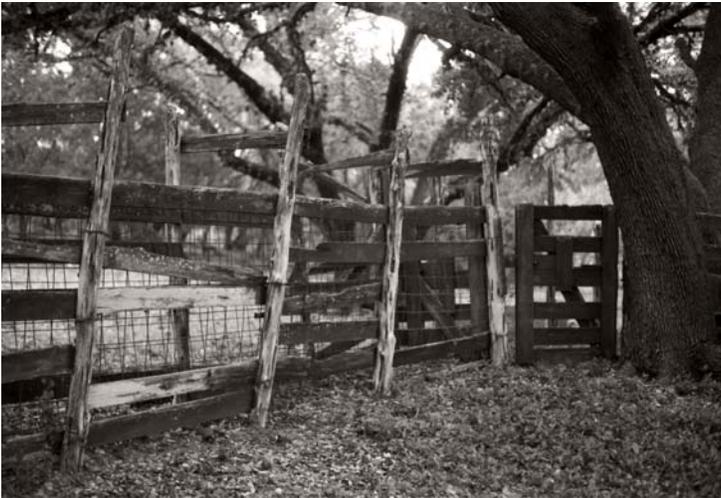
**Figure 40. Sheep chute. Photo by Laura Knott.**

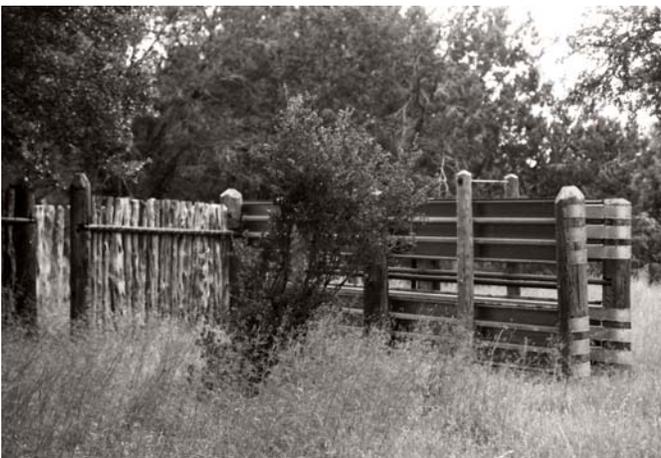
**Figure 41. Cattle chute. Photo by Laura Knott**
