# Cultural Landscape Report

## The Browning Ranch Blanco County, Texas

Laura Knott,  
Jeffrey Chusid  
and the  
University of Texas School of Architecture  
Historic Preservation Program  
Cultural Landscape Class of Spring, 2003.

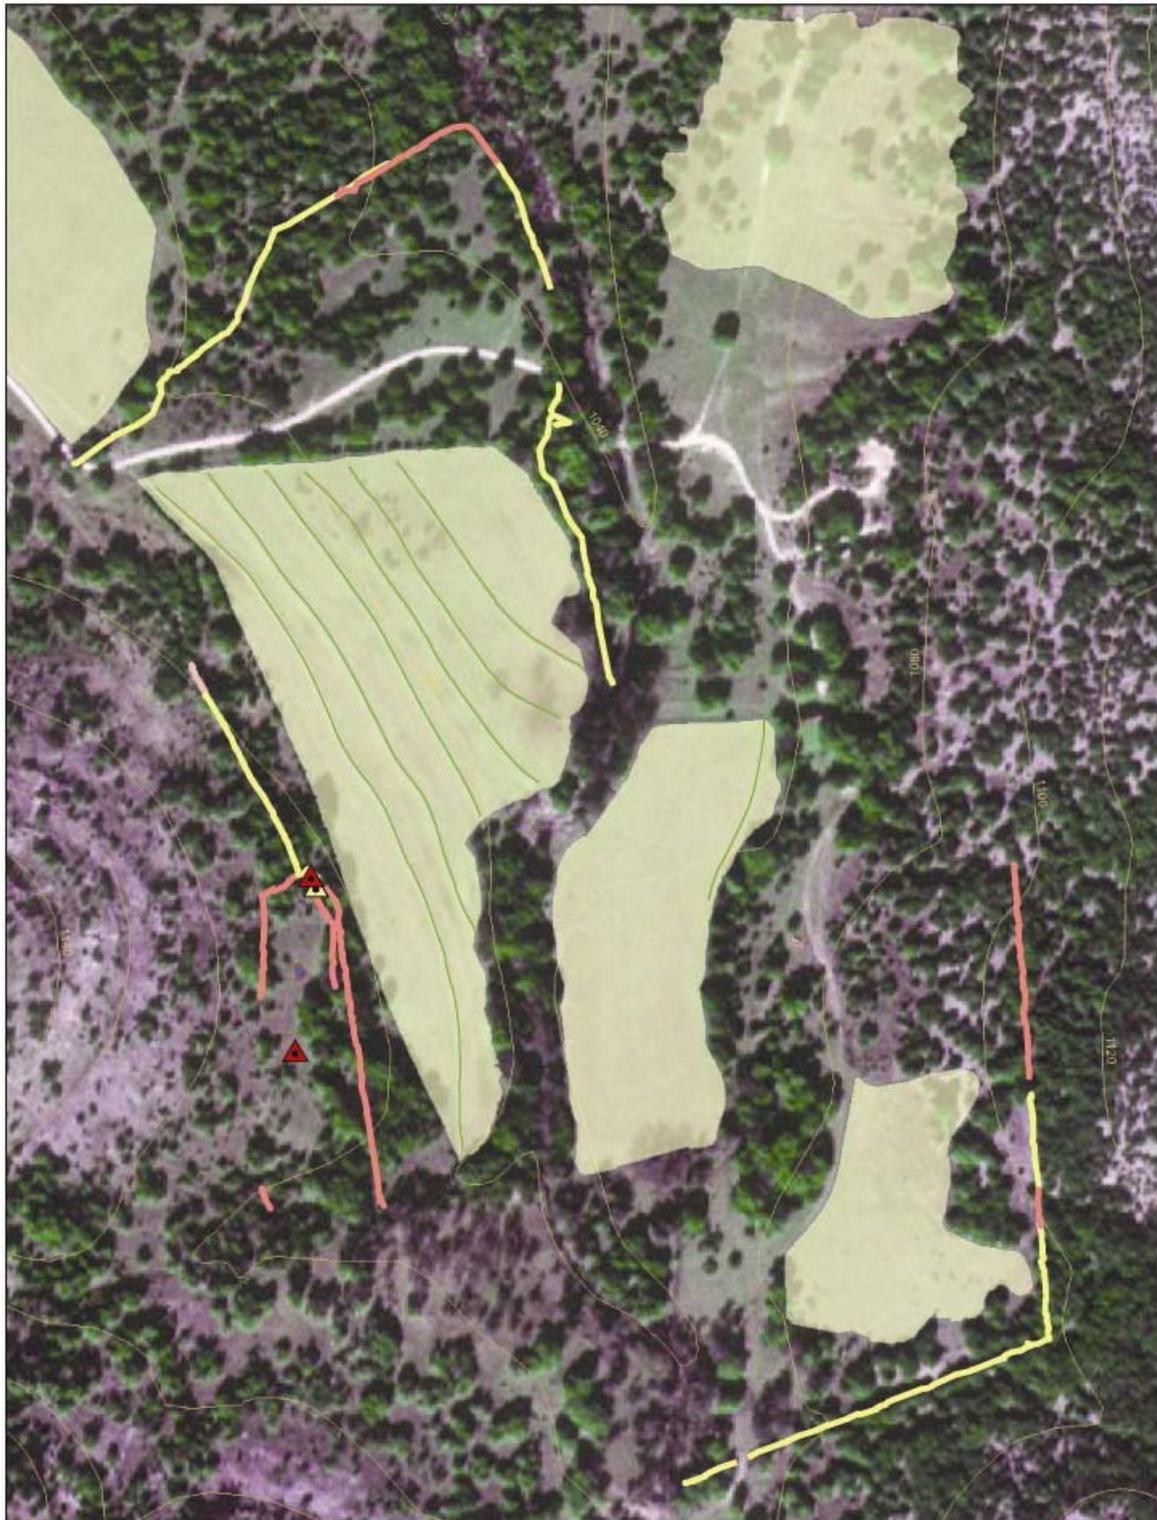
Less than ¼ mile east of the ranch house lie the remains of dry-stack limestone fences which appear to have formed a compound of fields and possibly pens for livestock (Figure 42).<sup>iv</sup> These fences outline a rough rectangle of about 85 acres, at the center of which is Hunnicutt Spring. The historical record refers to the Moursund family having lived at Hunnicutt Spring when they first came to the Johnson City area, and mentions that the old house that was there was in such poor condition that they had to live in a tent as a temporary residence. This house may have been located in very close proximity to this fence complex; no remains of a wooden structure have been found in the area, but there is a small rectangle of dressed limestone in the wall compound section, possibly indicating the location of a hearth.

There appear to be three distinct sections to this fence complex, the northern section, the wall compound, and the southern section. The northern section lies completely to the west of Hunnicutt Creek and roughly outlines what must have been cleared pasture at the time, which has since grown up in cedar (Figure 43). Also included within the boundaries of this section is Field Two, one of the terraced fields which will be discussed in more detail below. Although this field was most likely terraced in the 1950's, one might assume that when the fences were built, it too, was cleared of stones for crops or pasture. The stone used to build these fences appears to be flatter and more angular than that used for the other two sections, which is consistent with the exposed limestone bedrock of the Hunnicutt Formation in the immediate vicinity. The remaining portions of these fences are only 18" tall at the most, but were probably much taller, having been pushed down by the flooding of Hunnicutt Creek from time to time.

Figure 42. Map of fence complex. Compiled by Sylvia Guerrero.

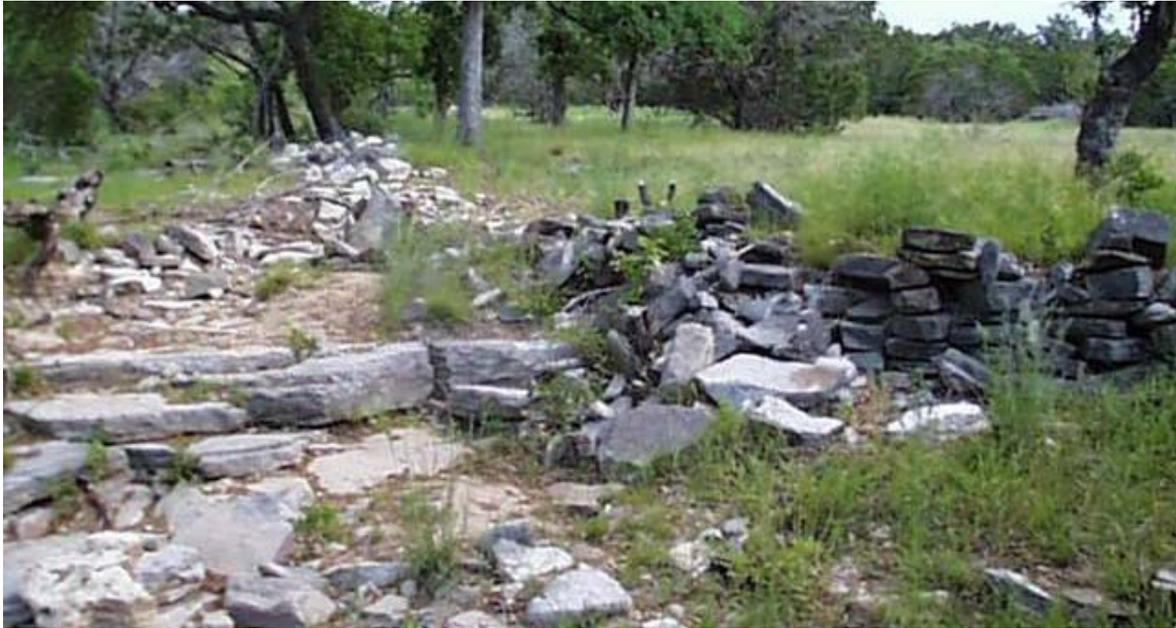
Figure 43. Stone fence in northern section. Photo by Kara Dotter.

In general, the fences and walls of the complex vary in width from around 16” to 24” and are consistently two courses wide when courses could be distinguished. Heights also vary, but one must take into account displacement as a result of natural and human forces over time. Eighty percent of the fence in the northern part of the ranch measures two feet tall or less, but the relatively short height is attributed to flooding from Hunnicutt Creek. In the stone complex area, portions of the wall are as tall as six feet, while other segments are less than one foot and have no logical termini, this attributed to the removal of stone from this area in the 1960’s. Because the fields contained within the stone fence boundaries have been cleared of stones, one can assume that the fences were constructed of this local material during the process of clearing.

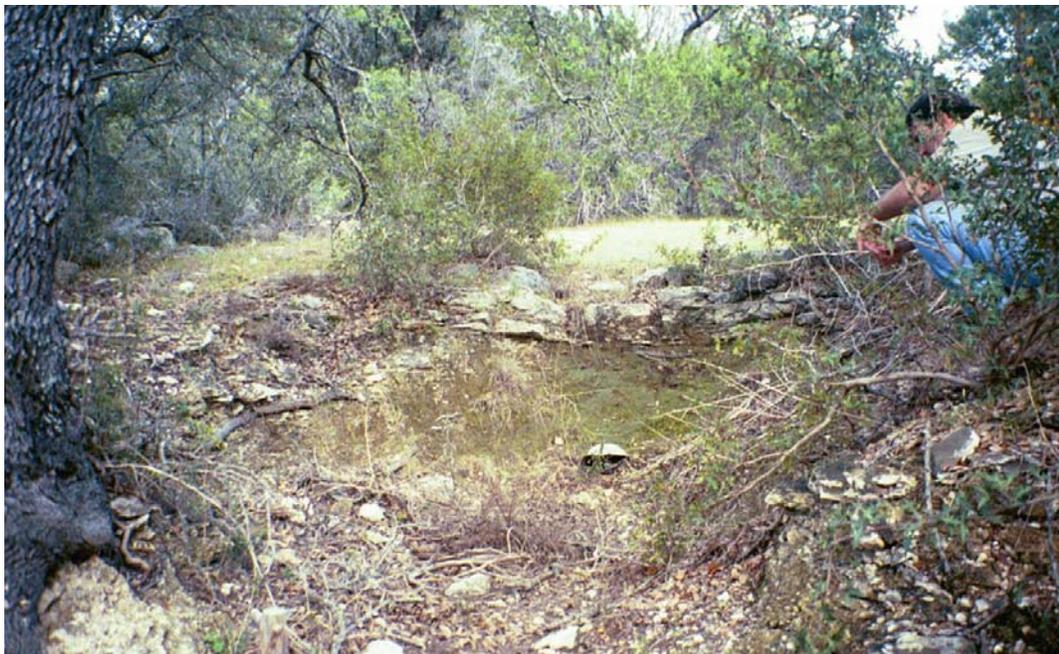
The southern fence section was built on both sides of the creek and appears to have been constructed up to the creek banks at one time; however, several hundred feet of fence are missing where some of the stone was removed for sale.<sup>22</sup> The stone used to construct these fences appears to be thinner and more varied in size than that used for the north fence and appears to have come from the Glen Rose Formation. Remaining sections of this fence are as tall as four feet in some areas (Figure 44). Much of this fence appears to follow an intermittent stream, which may have been diverted and the fence possibly used as a retaining device. The stream has since broken through the fence but it appears that it may have originally been stopped by a roughly constructed spring box structure (Figure 45).

Figure 45. Possible spring box structure. Photo by Adrienne Campbell

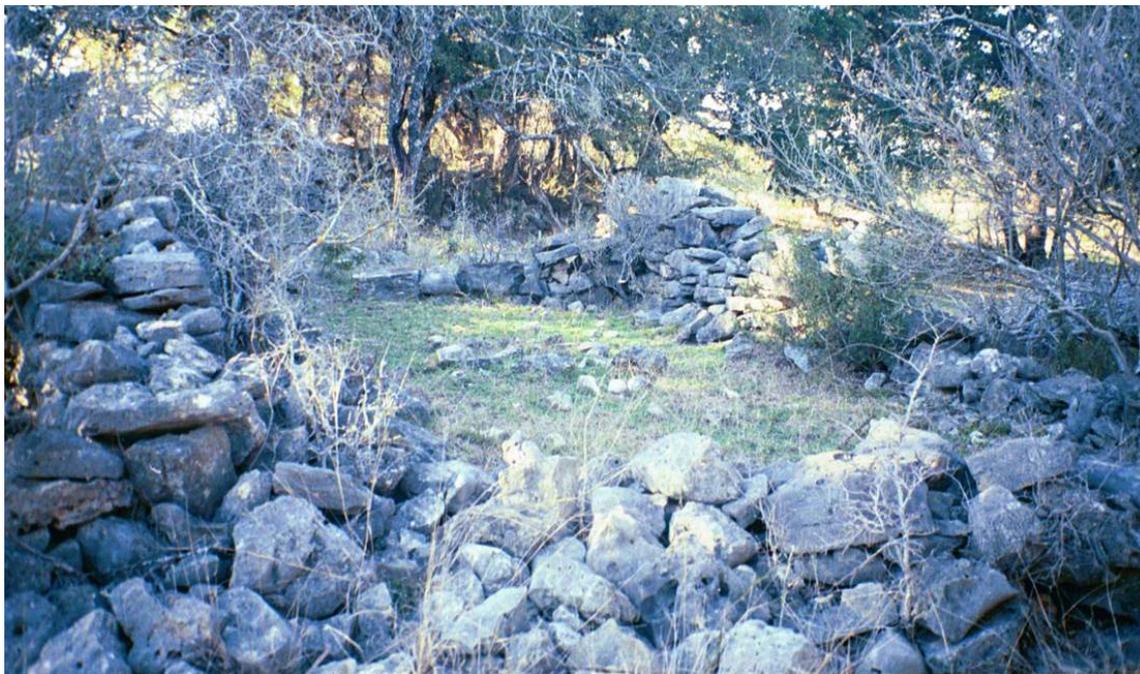
Figure 46. Possible structure in wall compound. Photo by Adrienne Campbell.

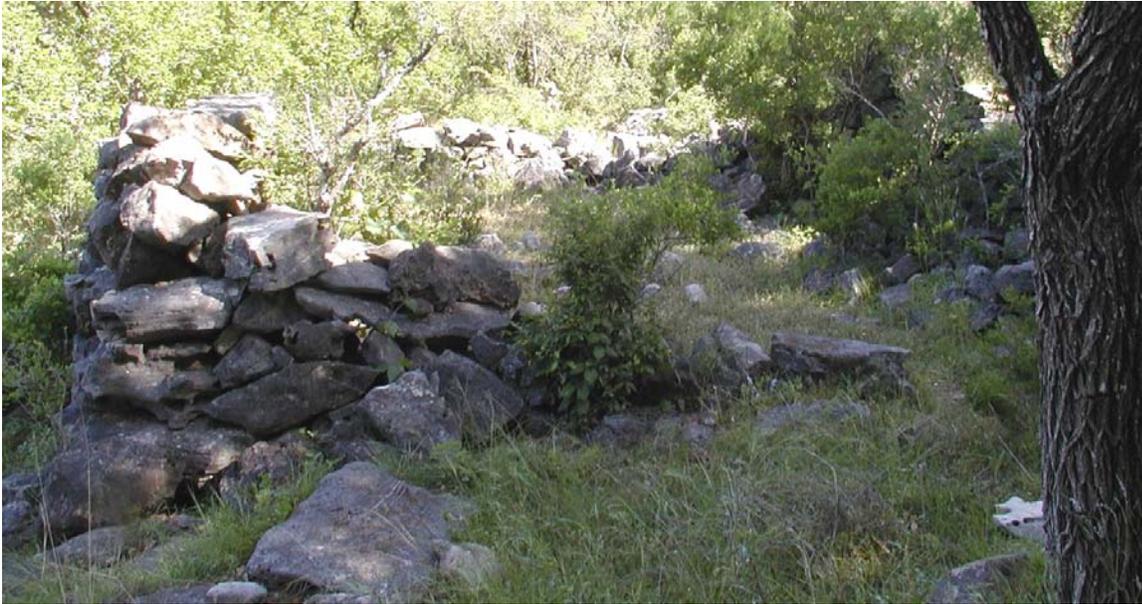
Figure 47. Structure in wall compound also acting as retaining wall. Photo by Adrienne Campbell.

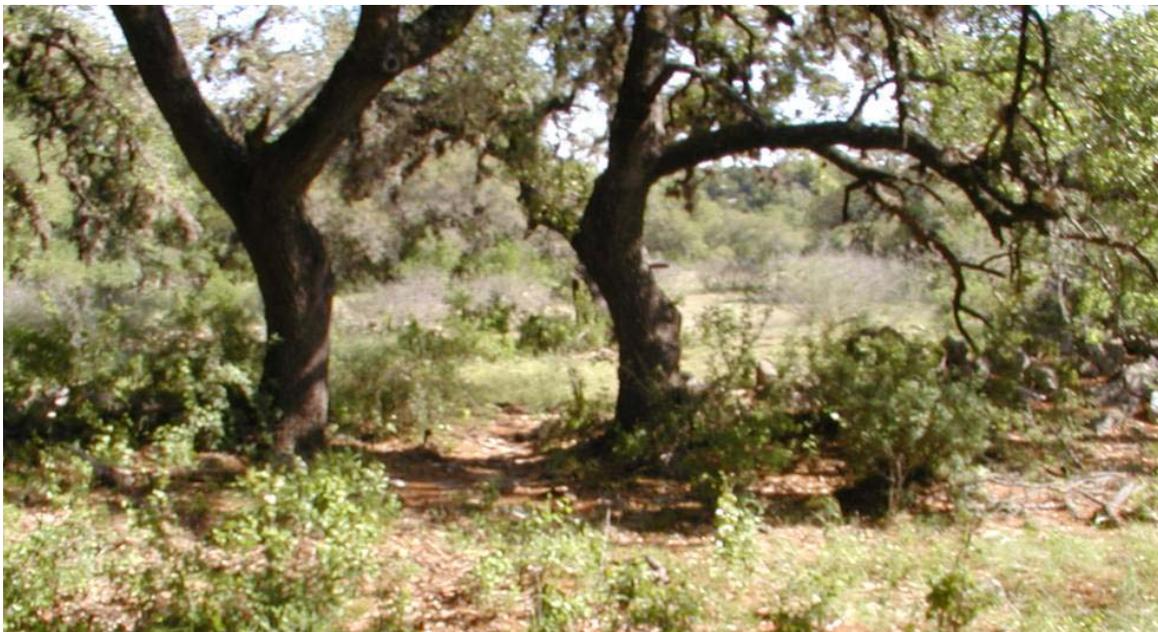
Figure 48. Gate in wall compound. Photo by Adrienne Campbell.

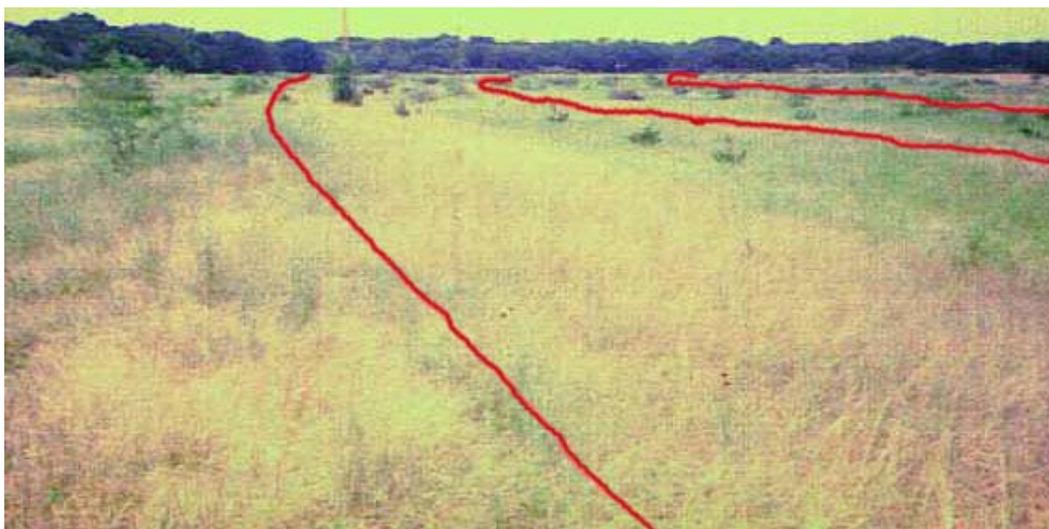
Fields One, Three, and Four are of special interest in that they are contour farmed and diversion terraced (Figure 50). Contour farming was promoted in the mid-20<sup>th</sup> century as a labor-saving tool and as a way to retain soil. The technique of diversion terracing is utilized to decrease soil loss but not retain water, instead, funneling water off the field to some outlet such as a stream.<sup>31</sup>

The terraces on the Browning Ranch, however, were a failed experiment; not only do they not strategically retain water in the field, but they are too high, causing trapped water to rush laterally downhill and thus washing soils away into Hunnicutt Creek. The terraced fields typically have grasses such as King Ranch bluestem and red threeawn on the drier down-slope terrace side, but prairie coneflower and other weeds tend to dominate the wetter up-slope side of the terrace and the swales. By early May, the two zones were visually distinctive in that the grassier slopes were brown and the weedier slopes were green.

Figure 50. Terraced field with graphic showing location of terraces. Compiled by Kara Dotter.

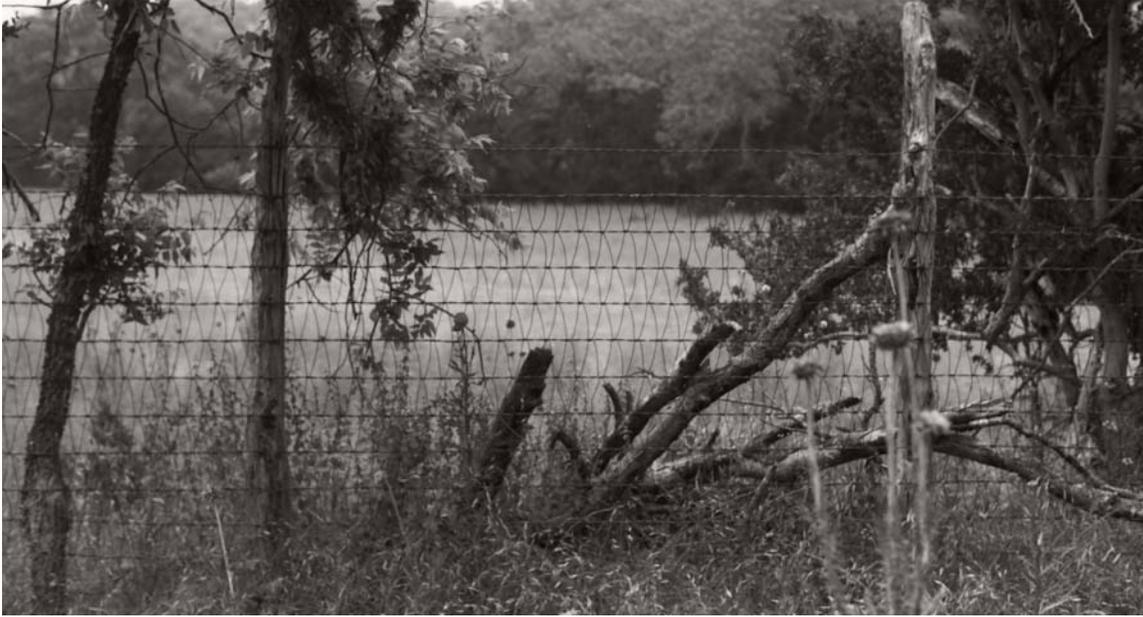
The Browning Ranch is criss-crossed by a complex of fences (Figure 51), made primarily of metal. All of the barbed wire found at the ranch is double-stranded and modern; the only difference noted among the samples is that the newer sections are galvanized. Most stretches of fencing are made of sheep wire, cattle wire, hog paneling, or rabbit wire and most are topped by at least two courses of the double-stranded barbed wire. Fence posts are made of either un-milled cedar or steel.

**Figure 52. Sheep wire fencing. Photo by Laura Knott.**

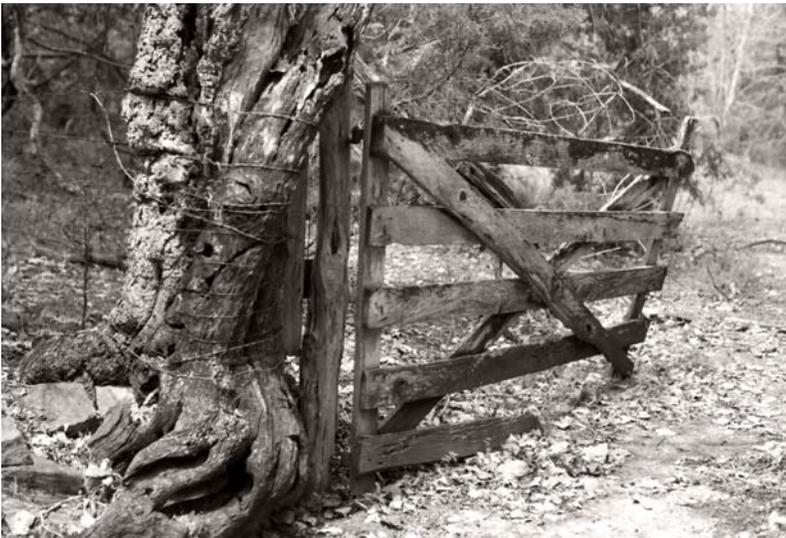
Special note should be made about the various gates found on the ranch, some of which contribute a great deal to the historic character of the ranch. Of particular interest is the old wooden gate which is encountered on the creek side path (Figure 53). Another interesting detail is the piece of machinery used as a weight to close the metal gate next to the garage (Figure 54). The gate to the orchard is distinctive in its simplicity (Figure 55). Finally, leaning on the north side of the sheep barn are what one might assume are the two original gates for that compound (Figure 56). This same construction can be seen on one of the pasture gates close to the western-most field.

**Figure 53. Old wooden gate on creek path. Photo by Laura Knott.**

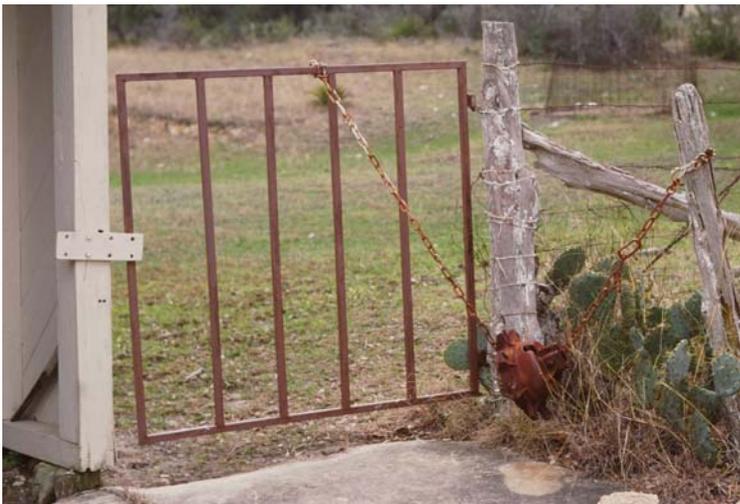
**Figure 54. Metal gate with weight. Photo by Laura Knott.**

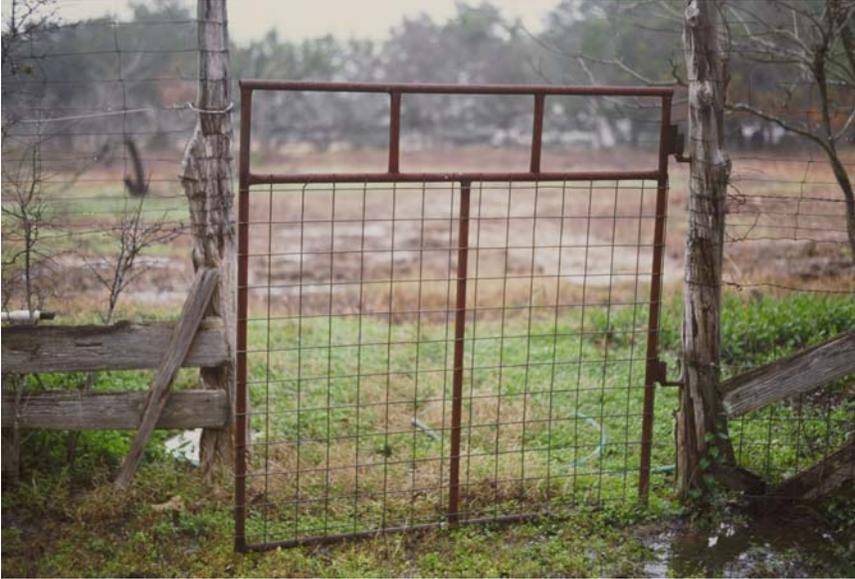
Figure 55. Metal gate at orchard. Photo by Laura Knott.

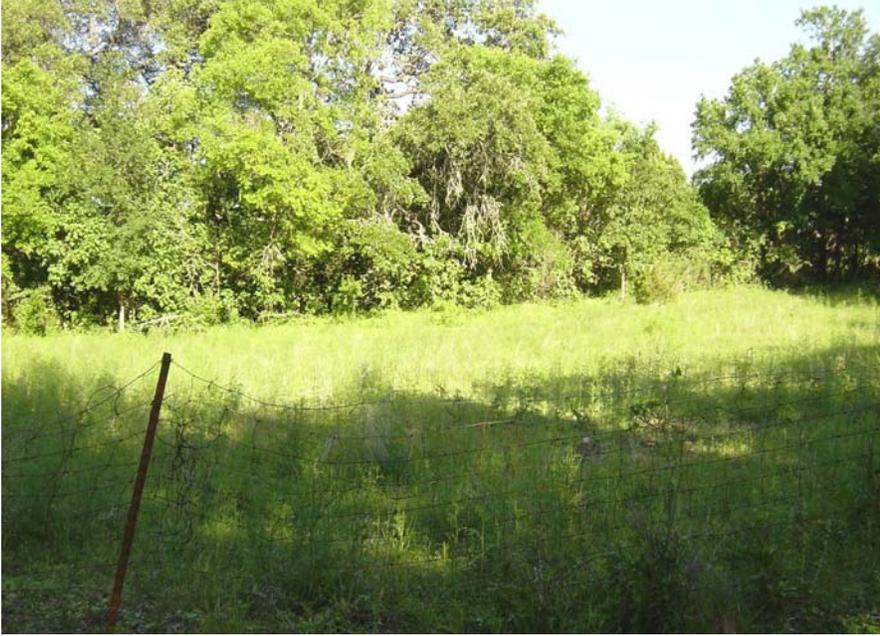
**Figure 64. Vegetable Garden. Photo by Terri Ruiz.**

The area where the vegetable garden once grew is now overgrown with weeds. The majority of the original, 3' 11"-high, barbed wire and steel fence is still standing, and the gate is still operational. The gate is placed on the southeast corner of the garden to allow access from the backyard of the original house.

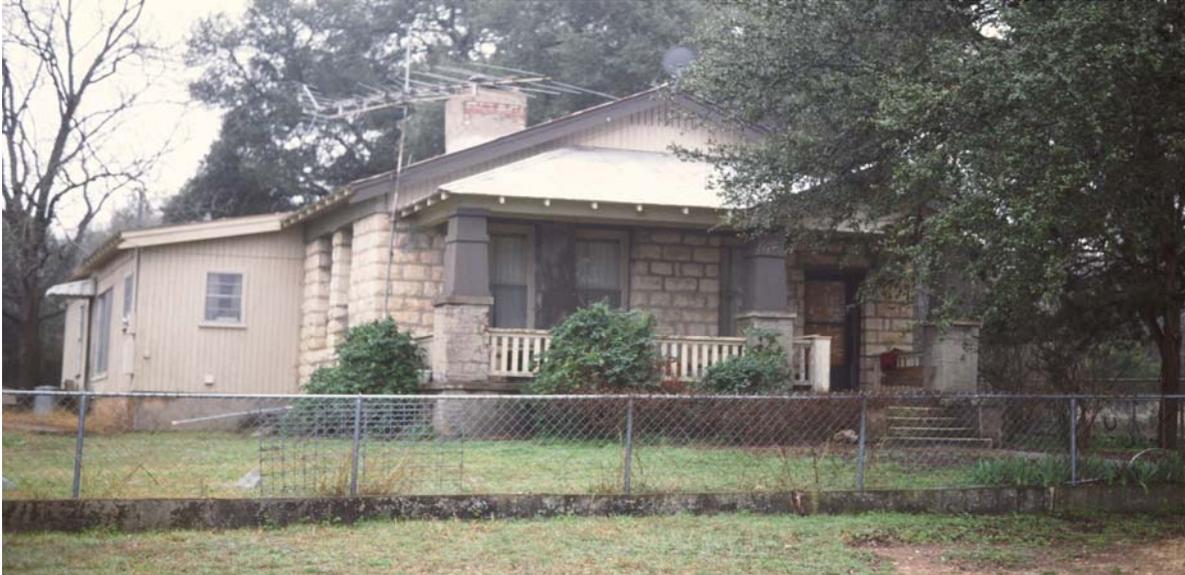
Figure 65. Chain link fence around Barnwell House.

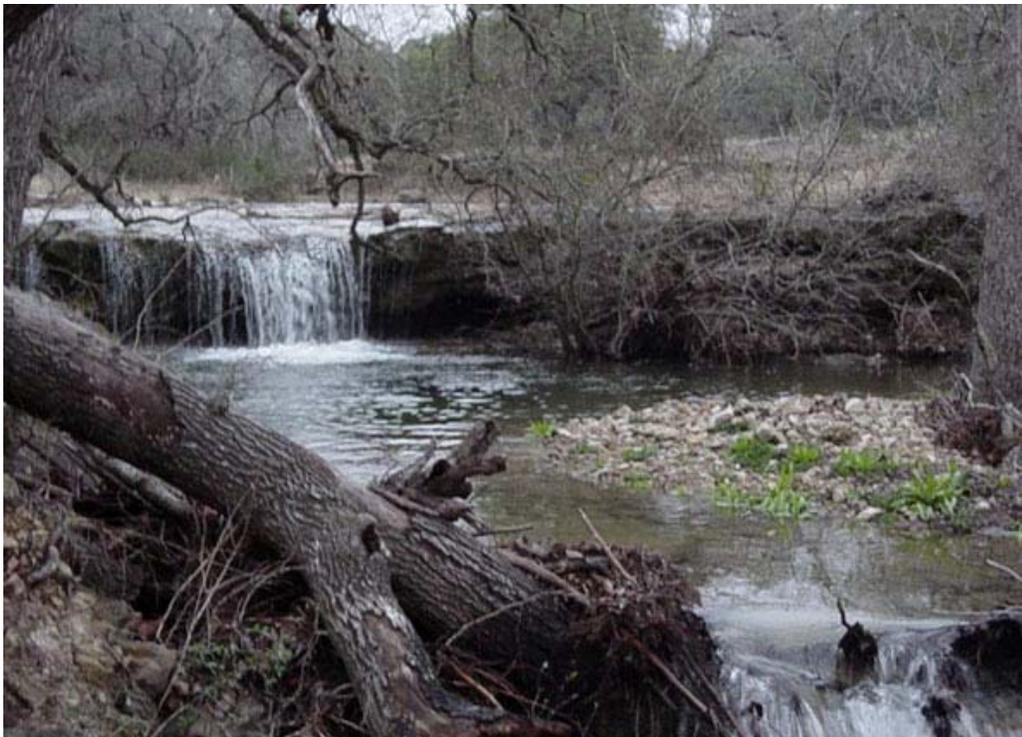
The major water feature on the Browning Ranch is Hunnicutt Creek (Figure 68), which, with its north-south orientation, divides the property into two unequal sections. The creek is intermittent, going dry above Hunnicutt Spring in the late spring until the rains begin again in the fall. During the fall, winter, and early spring, the creek is fed by all eleven of the springs and innumerable seeps found on the property which are active in the rainy season (Figure 69).

On its lower reaches, the banks of Hunnicutt Creek have been heavily silted in by soils coming off of the surrounding pastures, made worse by erosion from the field terraces. In these areas, the creek does not display the typical Hill Country creek appearance, that is, usually clear water to bedrock and lined with limestone boulders and gravel. The silt, as well as compaction and trampling by cattle allowed access to the water, may be one of the causes of the lack of diversity of riparian vegetation in the area.

**Figure 68. Hunnicutt Creek. Photo by Kara Dotter.**

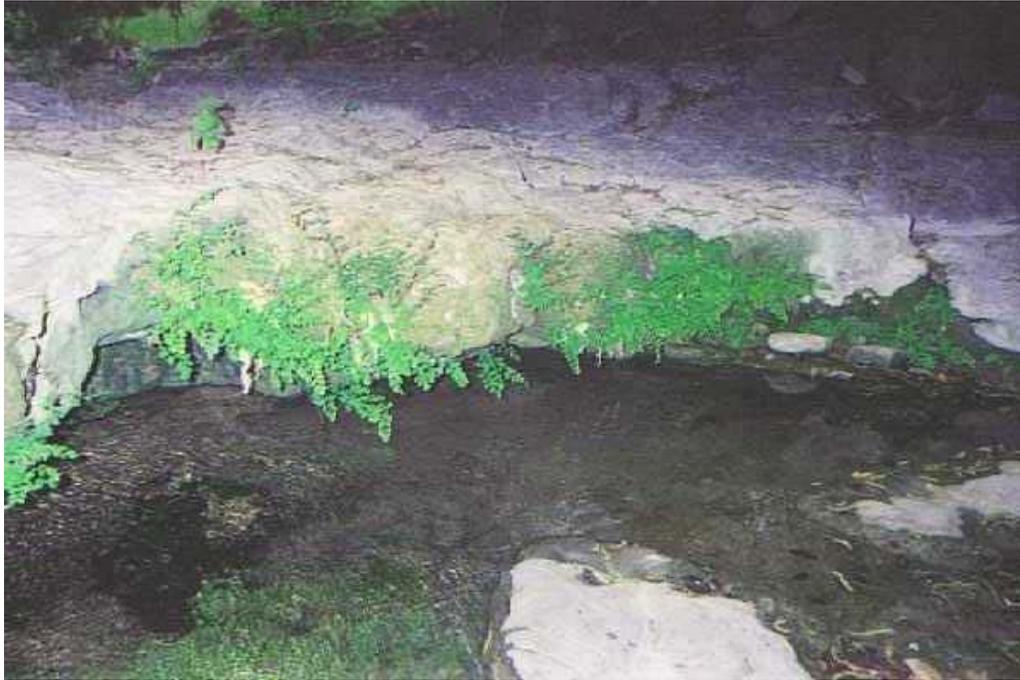
**Figure 71. Hunnicutt Spring. Photo by Kara Dotter.**

fills its adjoining cistern and an animal watering trough. This system appears to still be in fair operating condition.

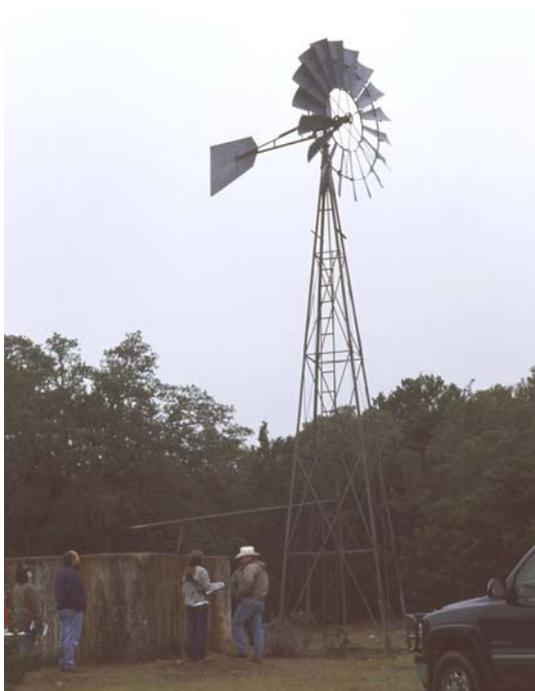
There are three pumping systems on the ranch, two electric pumps and a windmill system, located in the southern upland area of the ranch (Figure 72). A functioning electric pump, located on the lower slopes close to the ranch house, supplies all the drinking water to the ranch today. Another electric pump which, when it was operable, filled a cistern located above the Barnwell House and the water was gravity-fed to supply water needs around that building. The current owner recalls that catfish were often stored in this cistern. Although there is water in the cistern, it does not appear that this pump is still in working condition. The third system is a windmill, which, when in full operation,

**Figure 72. Windmill. Photo by Laura Knott.**

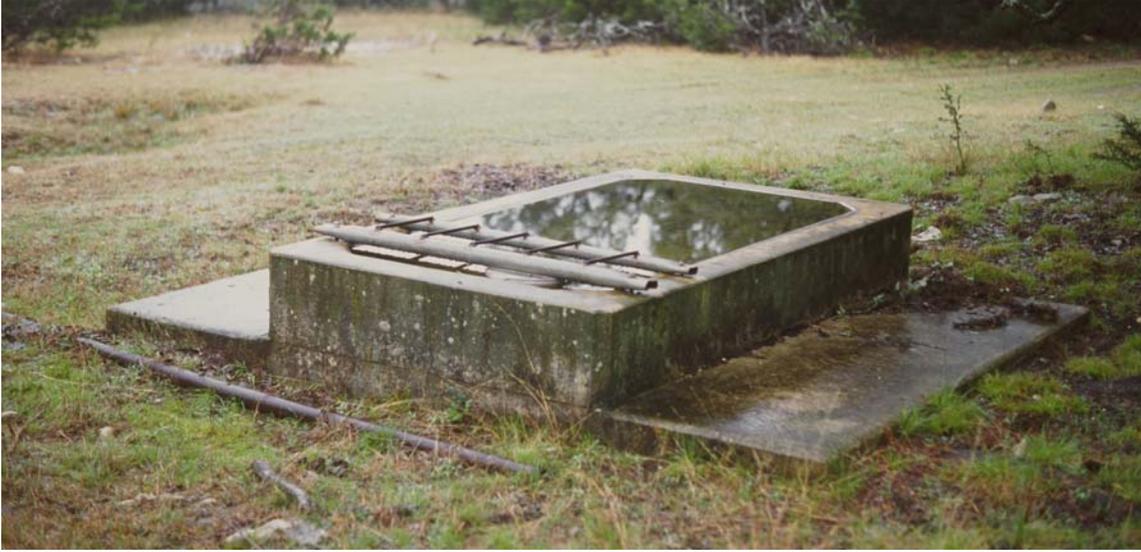
Other water features include concrete animal drinking troughs, hose bibs, and a feed line that once ran from a spring to supplement the creek flow in the summer for recreational purposes. The concrete drinking troughs were carefully designed with a float system that, when low enough, would automatically turn on the water supply to keep them filled. They were also designed with a low step on one side so that the trough could be accessed not only by cattle, but by smaller animals such as deer and other wild species (Figure 73).

**Figure 73. Animal watering trough. Photo by Laura Knott.**
